FIRE CHIEFS
investigate, demonstrate and
SPEAK OUT
ON FIRE SAFETY.

OPERATION SAN FRANCISCO

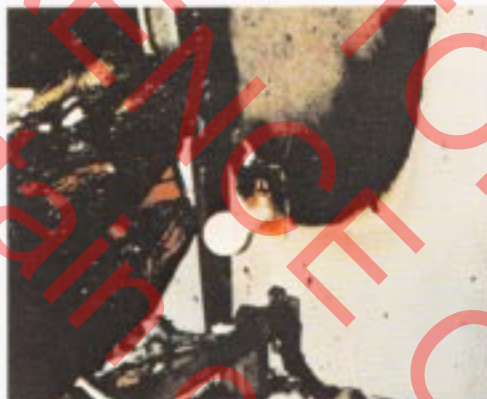
1 This wall receptacle in the apartment master bedroom shows the extent of fire damage to bed frame, wall and outlet plate, while circuit operation is demonstrated by light. Recorded room temperatures are shown in Graph A. See Diagram II.

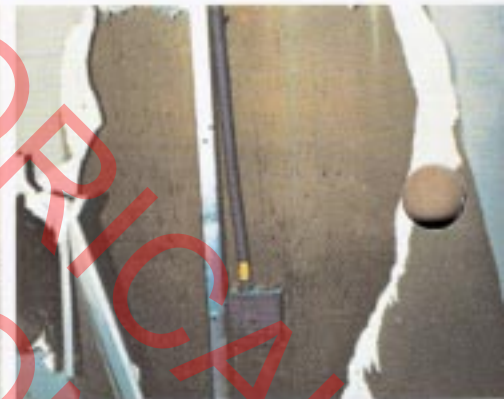
2 This is the reverse side of photo #1 showing the reverse side of the wall and tubing intact and undamaged. See Diagram II.

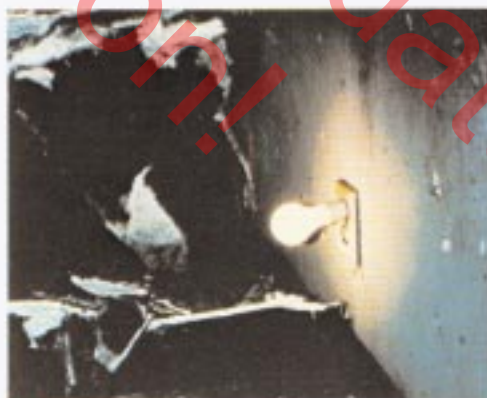
5 This receptacle is located in room 206 and is operative after flashover. Room temperatures during flashover shown in Graph B. See Diagram II.

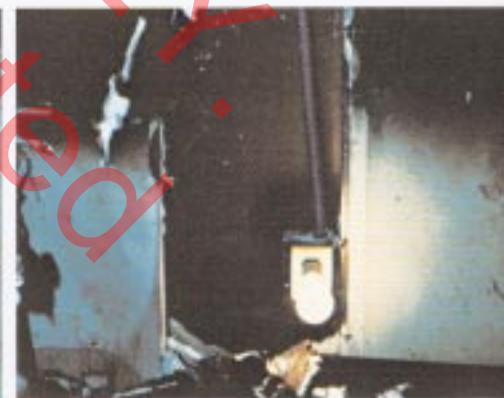
7 This photo shows same receptacle as photo #5, but the wall board was removed to show wiring and box intact. See Diagram II.

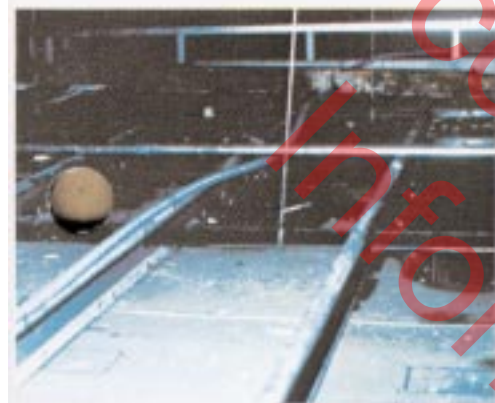
3 Electrical nonmetallic tubing running across ceiling of apartment master bedroom showing effects of fire but tubing intact. See Diagram II.

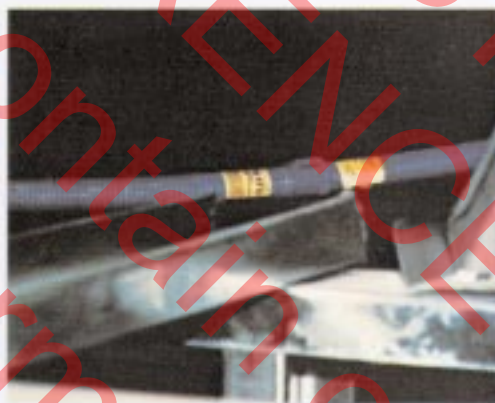
4 ENT™ running above apartment bedroom showing coupling for tubing. See Diagram II.

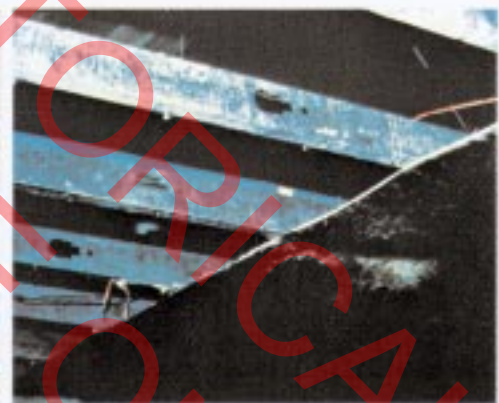
5 The raceway in this photo is mounted above room 206. This room was one picked for a flashover fire on final day. See Diagram II and Graph B.

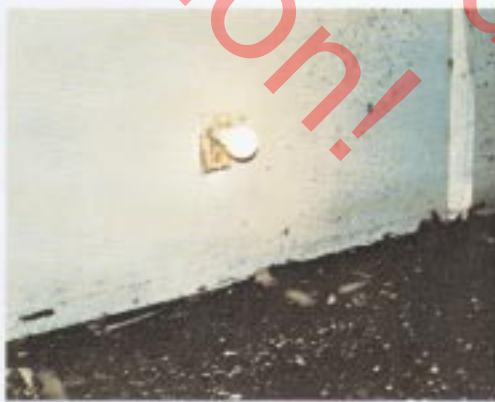
9 Outlet box in Blue Ballroom still functioning after final room burn (flashover). Temperatures are recorded in Graph C. See Diagram I.

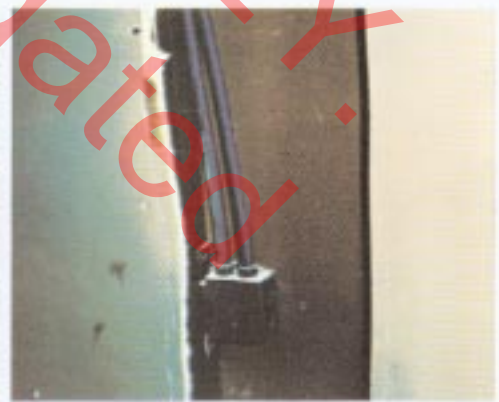
10 Outlet box shown in photo 9 from exterior of room with wall board cut away to show box and tubing still undamaged. See Diagram I.
