FIRE CHIEFS
investigate, demonstrate and
SPEAK OUT
ON FIRE SAFETY.

A documentation of actual tests,
demonstrations and results from segments of

OPERATION SAN FRANCISCO

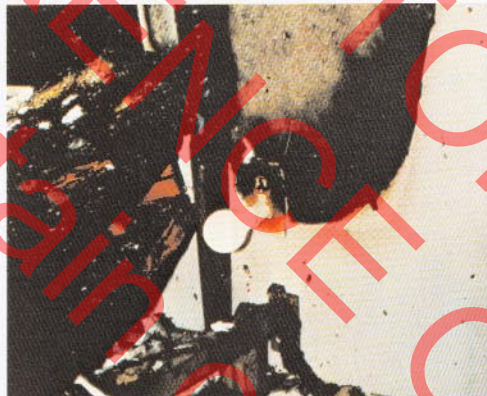
1 This wall receptacle in the apartment master bedroom shows the extent of fire damage to bed frame, wall and outlet plate, while circuit operation is demonstrated by light. Recorded room temperatures are shown in Graph A. See Diagram II.

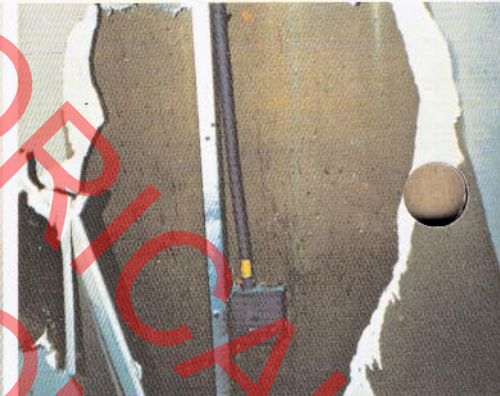
2 This is the reverse side of photo #1 showing circuit box and tubing intact and undamaged. See Diagram II.

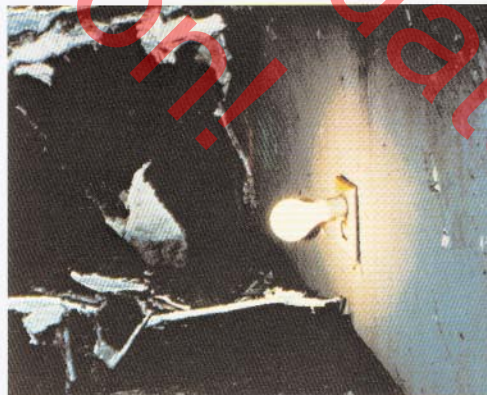
6 This receptacle is located in room 206 and is operative after flashover. Room temperatures during flashover shown in Graph B. See Diagram II.

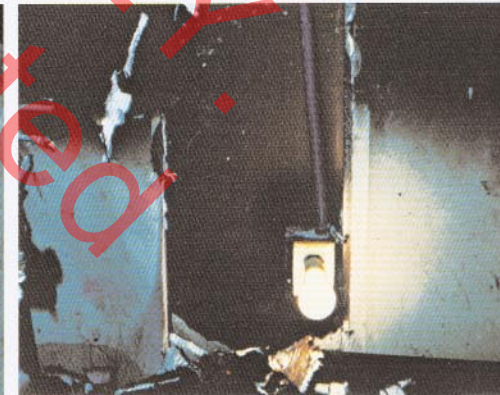
7 This photo shows same receptacle as photo 6, but the wall board was removed to show wiring and box intact. See Diagram II.

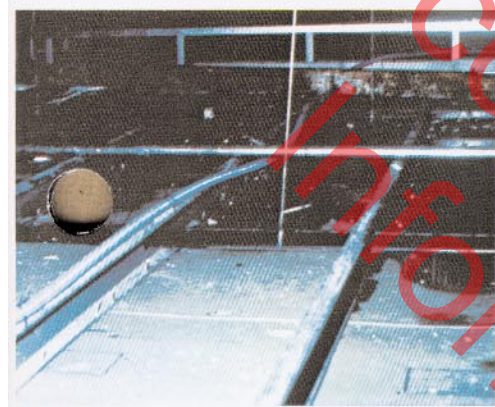
3 Electrical nonmetallic tubing running across ceiling of apartment master bedroom showing effects of fire but tubing intact. See Diagram II.

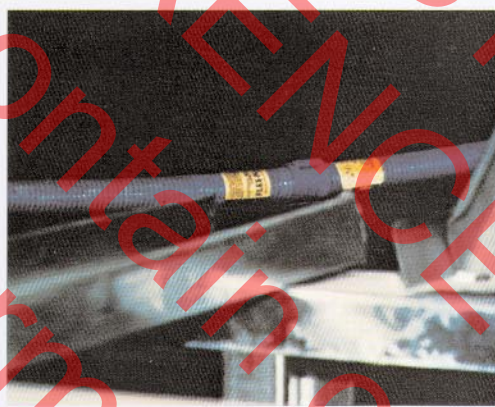
4 ENT™ running above apartment bedroom showing coupling for tubing. See Diagram II.

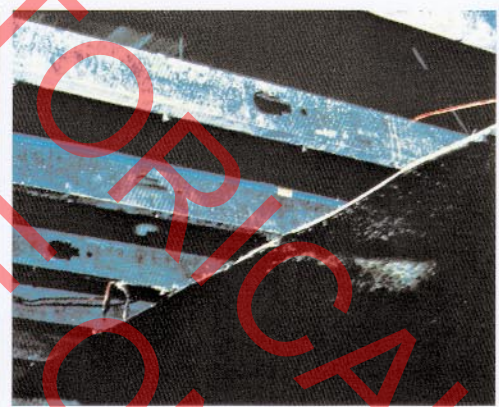
5 The raceway in this photo is mounted above room 206. This room was one picked for a flashover fire on final day. See Diagram II and Graph B.

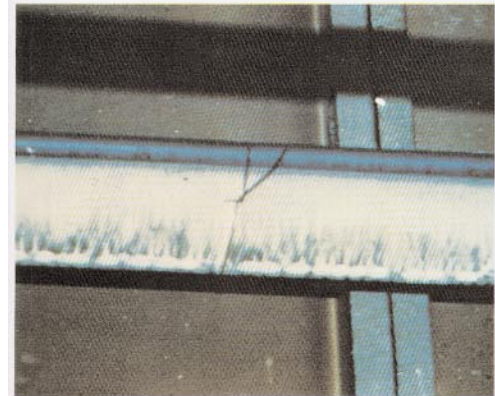
8 Tubing secured to pipe above Blue Ballroom feeding four outlet and switch boxes in room. See Diagram I and Graph C.

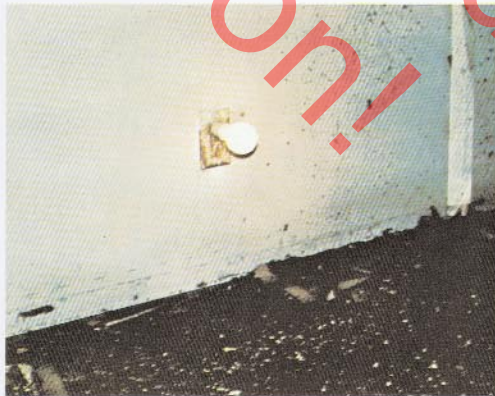
9 Outlet box in Blue Ballroom still functioning after final room burn (flashover). Temperatures are recorded in Graph C. See Diagram I.

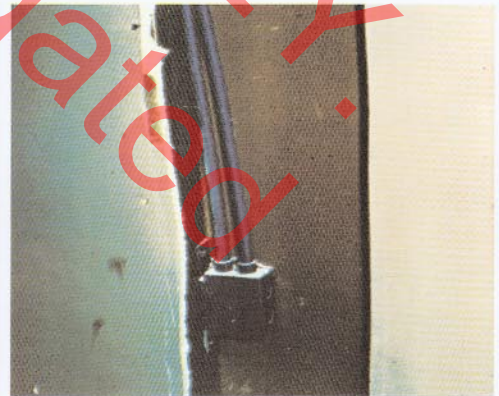
10 Outlet box shown in photo 9 from exterior of room with wall board cut away to show box and tubing still undamaged. See Diagram I.
