FIRE CHIEFS
investigate, demonstrate and
SPEAK OUT
ON FIRE SAFETY.

OPERATION SAN FRANCISCO

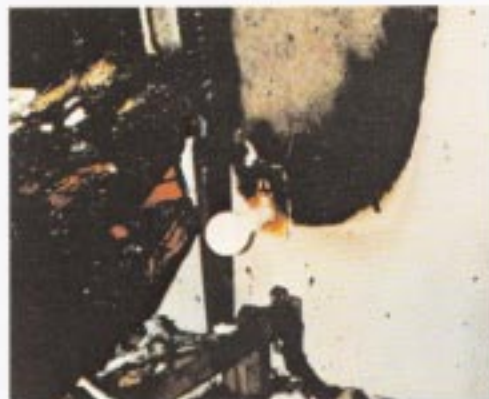
① This wall receptacle in the apartment master bedroom shows the extent of fire damage to bed frame, wall and outlet plate, while circuit operation is demonstrated by light. Recorded room temperatures are shown in Graph A. See Diagram II.

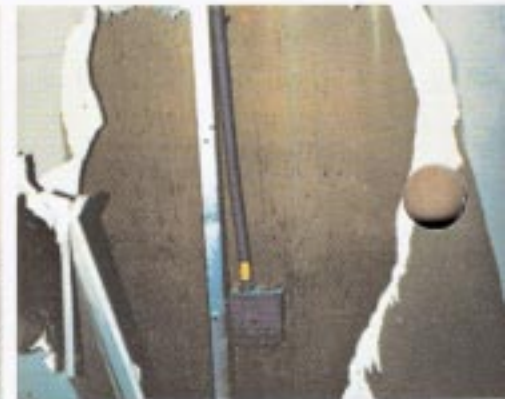
② This is the reverse side of photo #1 showing the extent of fire damage to bed frame, wall and outlet plate, while circuit operation is demonstrated by light. Recorded room temperatures are shown in Graph A. See Diagram II.

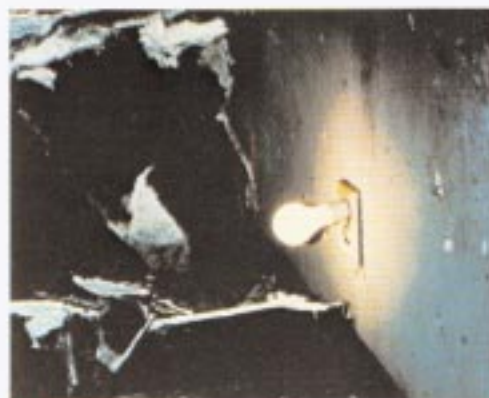
⑥ This receptacle is located in room 206 and is operative after flashover. Room temperatures during flashover shown in Graph B. See Diagram II.

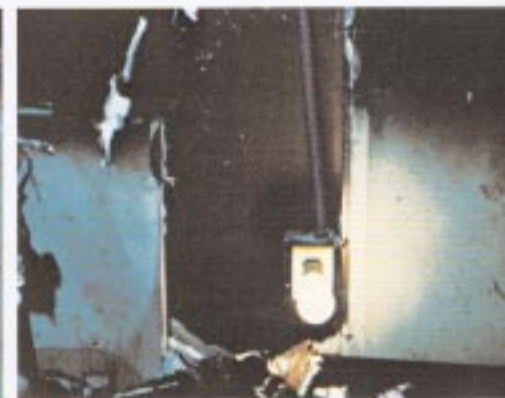
⑦ This photo shows same receptacle as photo #6, but the wall board was removed to show wiring and box intact. See Diagram II.

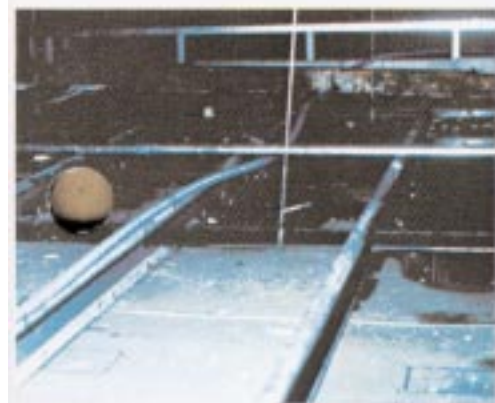
3 Electrical nonmetallic tubing running across ceiling of apartment master bedroom showing effects of fire but tubing intact. See Diagram II.

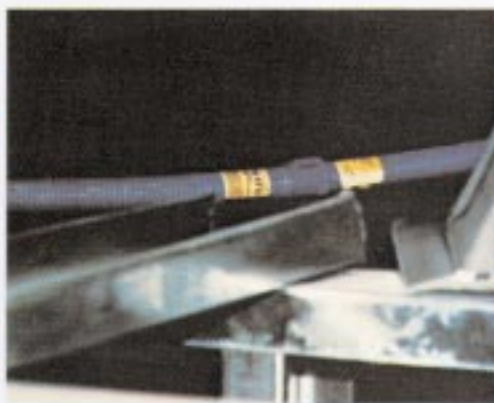
4 ENT™ running above apartment bedroom showing coupling for tubing. See Diagram II.

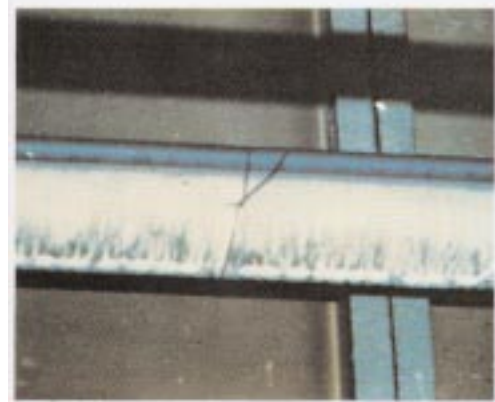
6 ENT™ secured to pipe above Blue Ballroom feeding four outlet and switch boxes in room. See Diagram I and Graph C.

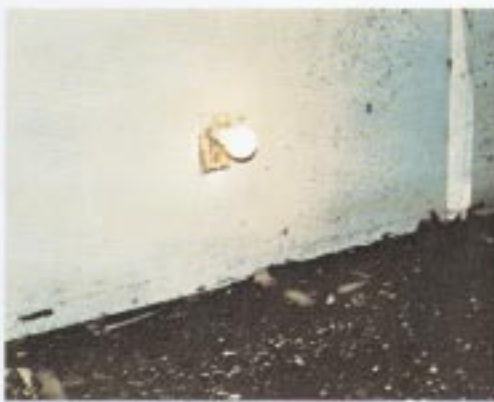
9 Outlet box in Blue Ballroom still functioning after final room burn (flashover). Temperatures are recorded in Graph C. See Diagram I.
