FIRE CHIEFS
investigate, demonstrate and
SPEAK OUT
ON FIRE SAFETY.

OPERATION SAN FRANCISCO

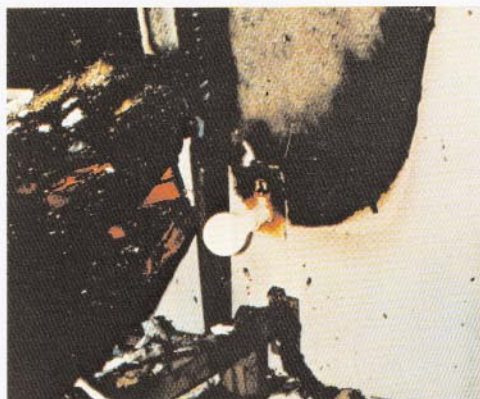
① This wall receptacle in the apartment master bedroom shows the extent of fire damage to bed frame, wall and outlet plate, while circuit operation is demonstrated by light. Recorded room temperatures are shown in Graph A. See Diagram II.

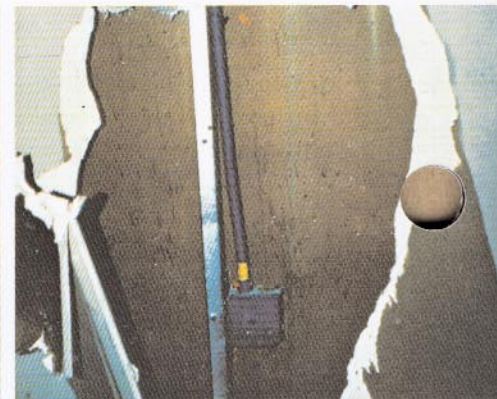
② This is the reverse side of photo #1 showing box and tubing intact and undamaged. See Diagram II.

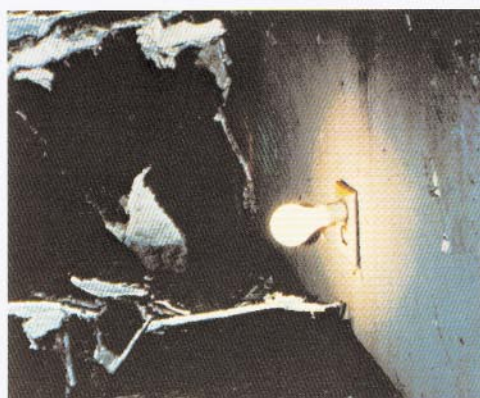
⑥ This receptacle is located in room 206 and is operative after flashover. Room temperatures during flashover shown in Graph B. See Diagram II.

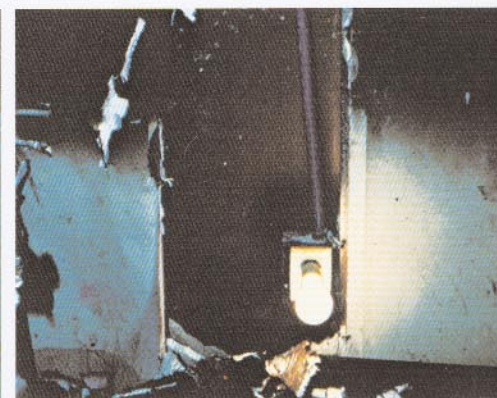
⑦ This photo shows same receptacle as photo 6, but the wall board was removed to show tubing and box intact. See Diagram II.

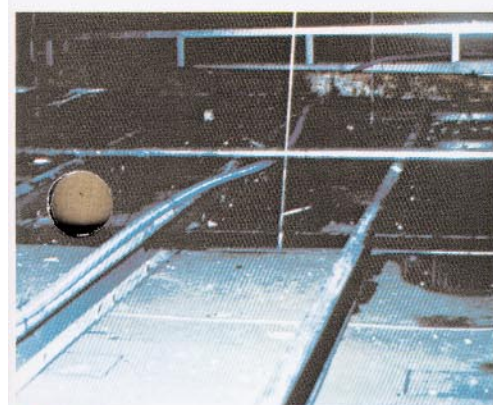
3 Electrical nonmetallic tubing running across ceiling of apartment master bedroom showing effects of fire but tubing intact. See Diagram II.

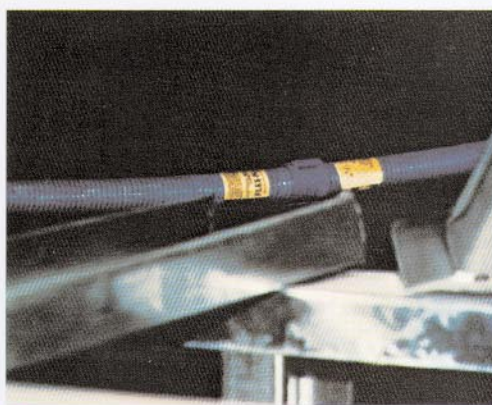
4 ENT™ running above apartment bedroom showing coupling for tubing. See Diagram II.

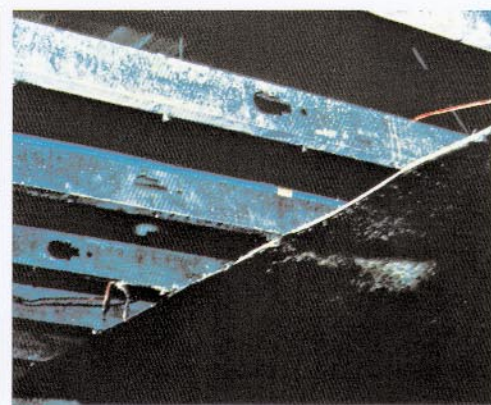
5 The raceway in this photo is mounted above room 206. This room was one picked for a flashover fire on final day. See Diagram II and Graph B.

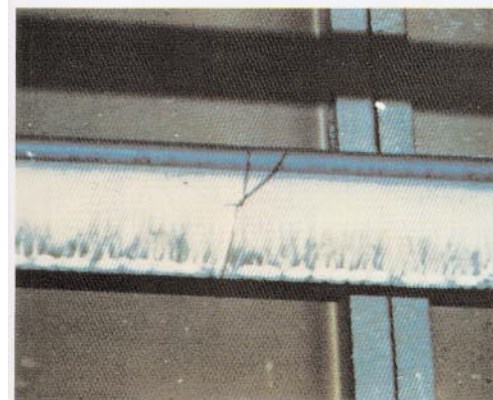
8 Raceway secured to pipe above Blue Ballroom feeding four outlet and switch boxes in room. See Diagram I and Graph C.

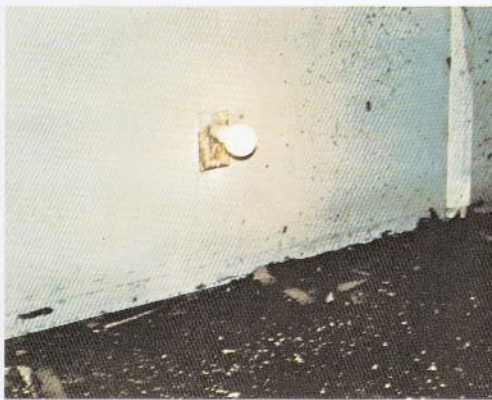
9 Outlet box in Blue Ballroom still functioning after final room burn (flashover). Temperatures are recorded in Graph C. See Diagram I.

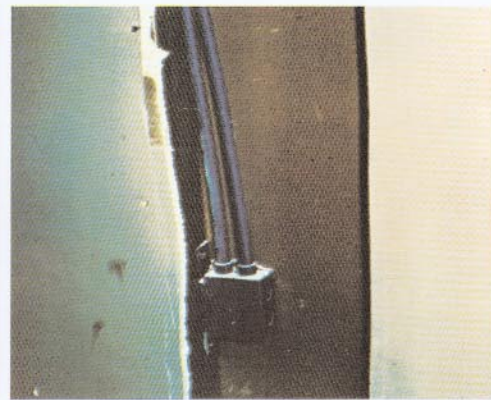
10 Outlet box shown in photo 9 from exterior of room with wall board cut away to show box and tubing still undamaged. See Diagram I.
