TRIAL BY FIRE

When fire breaks out every second counts. Recent fire tests, conducted by an independent testing laboratory, show that Electrical Non-metallic Tubing (ENT) and PVC Conduit protect electrical circuits longer than Electrical Metallic Tubing (EMT) and Intermediate Metallic (IMC) Conduit.

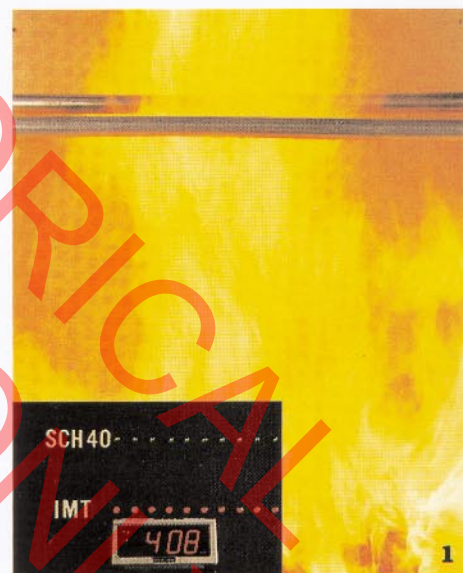
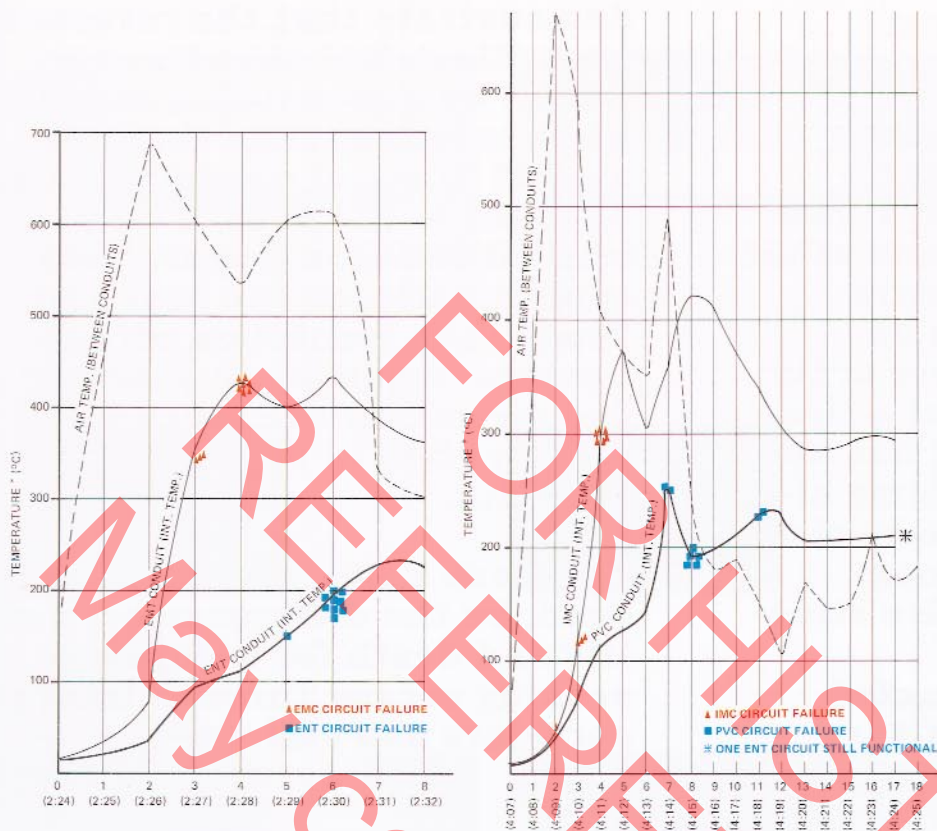
TEST NO. 1 TIME VS. TEMPERATURE CURVES (SEE CURVES FOR IDENTIFICATION)

Temperature curves plotted from the test data show that after two minutes of exposure to the flames, the internal temperature of the metallic conduit far exceeds the internal temperature of the non-metallic conduit which does not conduct heat as readily.

* Conduit temperatures are measured internally by IC thermocouples placed inside the individual test sections. Air temperatures are measured by IC thermocouples outside and equally spaced between the conduit test sections. (Thermocouple and thermocouple shield can be seen in photos between conduits.)

As could be expected, when the air temperatures in both test rose to in excess of 600°C, the internal temperatures of the test specimens, as measured by their respective thermocouples, also rose sharply. The slope of both the EMT and the IMC curves, however, were greater than the slopes of their non-metallic counterparts

and the internal temperatures of the metallic test specimens, in both tests, were considerably higher than the temperatures measured in the non-metallic test specimens (see time vs. temperature curves Test No. 1 and Test No. 2).

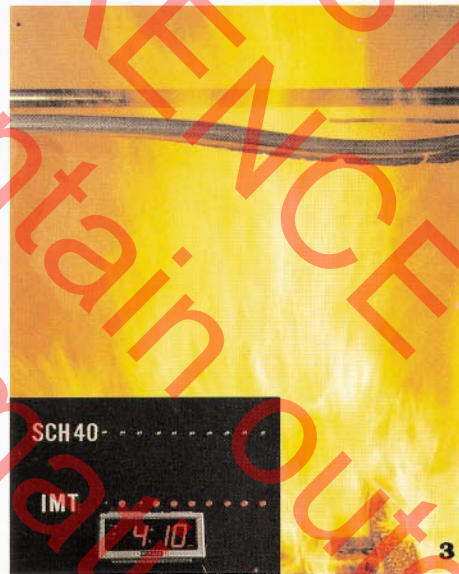
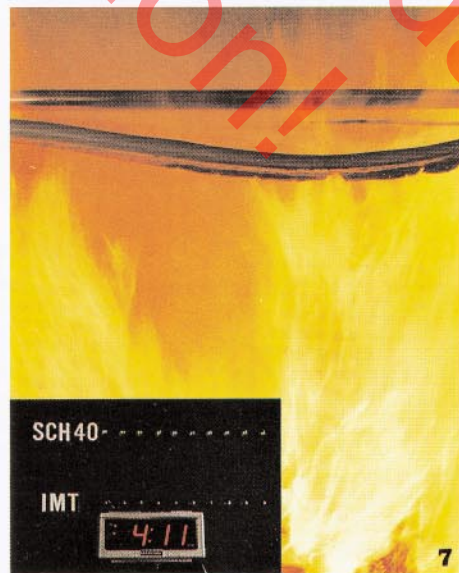
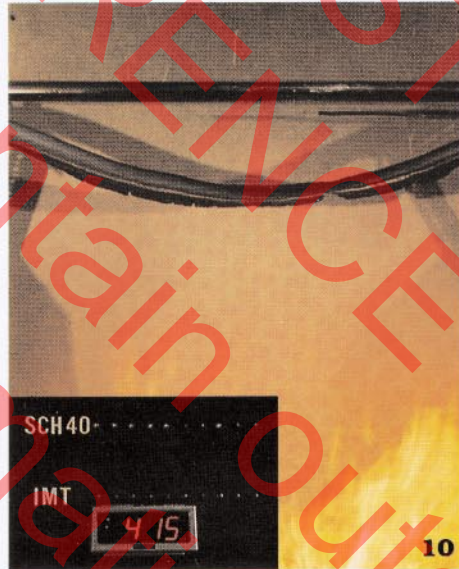
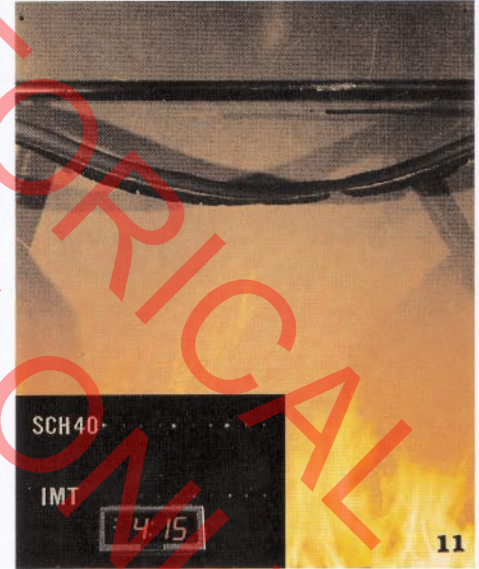
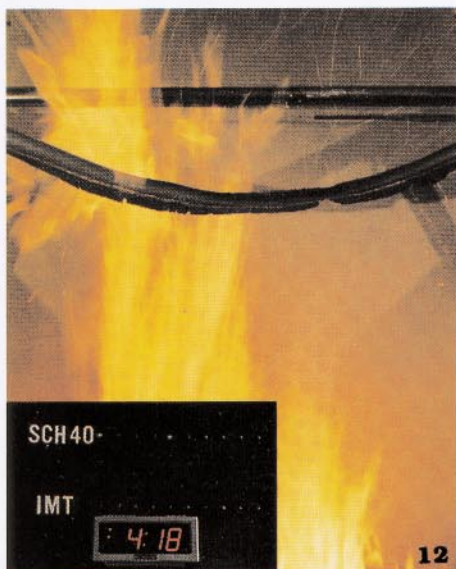
Test No. 2—Continued on Pg. 5

As shown by panel 1, all 10 circuits (red indicator lights) in the IMC conduit and all 10 circuits (green indicator lights) in the schedule 40 PVC conduit were functional at 4:08 one minute into the test.

As shown by panel 2, at 4:09, 2 minutes into the test the first circuit failed in the IMC conduit. The second circuit in the IMC conduit failed at 4:10 (see panel 3) followed by two additional circuit failures in the third minute of the test (see panel 4). At 4:11 (see panels 5, 6, and 7) the remaining circuits in the IMC conduit failed. **Significantly, not a single circuit in the schedule 40 PVC conduit had failed up to that point.**

At 4:14, seven minutes into the test, the first circuit in the schedule 40 PVC failed, quickly followed by a second circuit failure (panel 9), followed by five circuit failures at 4:15 (panels 10 and 11). Two of the remaining three circuits in the schedule 40 PVC failed at 4:18 (see panels 12 and 13). The last remaining circuit in the schedule 40 PVC conduit (panel 14) remained illuminated when the test was terminated at 4:24.

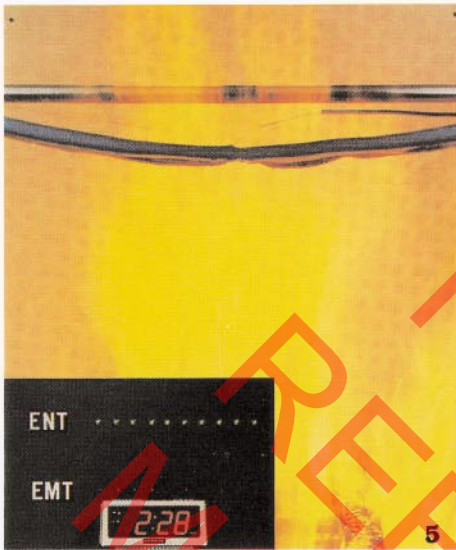
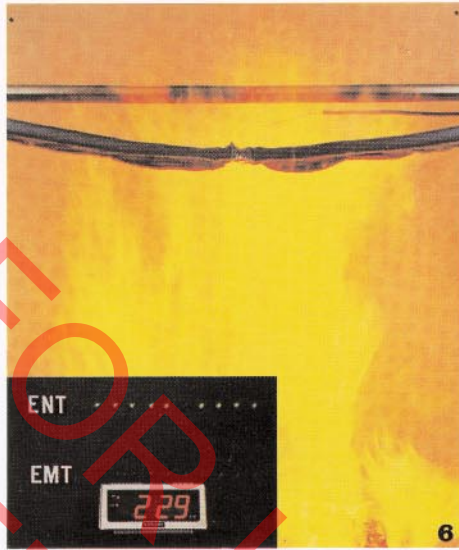
Test No. 1—Continued on Pg. 5

As shown by panel 1, all 10 circuits (green indicator lights) in the ENT conduit, and all 10 circuits (red indicator lights) in the EMT conduit were functional at the beginning of the test at 2:24. Panel 2 shows the first circuit failure in the EMT conduit at 2:27 three minutes into the test. Two additional EMT circuit failures followed rapidly (see panel 3).

At 2:28, four minutes into the test, all 10 circuits in the EMT had failed (panels 4 & 5). **Significantly, not a single circuit in the ENT conduit had failed at this time.**

At 2:29 (panel 6) the first circuit in the ENT conduit failed. At 2:30 (panel 7) all the remaining circuit indicator lights monitoring circuit integrity in the ENT conduit extinguished.

NOTE: The remaining circuits in the ENT conduit went dark simultaneously indicating a main fuse failure.
