**FIRE PERFORMANCE
OF
FIRE RESISTIVE CONCRETE SLAB ASSEMBLIES
WITH PVC RACEWAYS INSTALLED**

Ref: IFT 86-38D

REPORT OF THE PILOT SCALE FIRE ENDURANCE TEST
OF AN UNRESTRAINED 6' BY 8' BY 4-1/2" THICK,
REINFORCED CONCRETE SLAB WITHOUT AN APPLIED LOAD,
AND WITH 1" DIAMETER, PVC, FLEXIBLE, ENT CONDUIT RUNS

FILE NUMBER: WHI-495-PSH-0165
WORK ORDER NUMBER: 50611-C7-030320
DATE TESTED: MAY 7, 1990

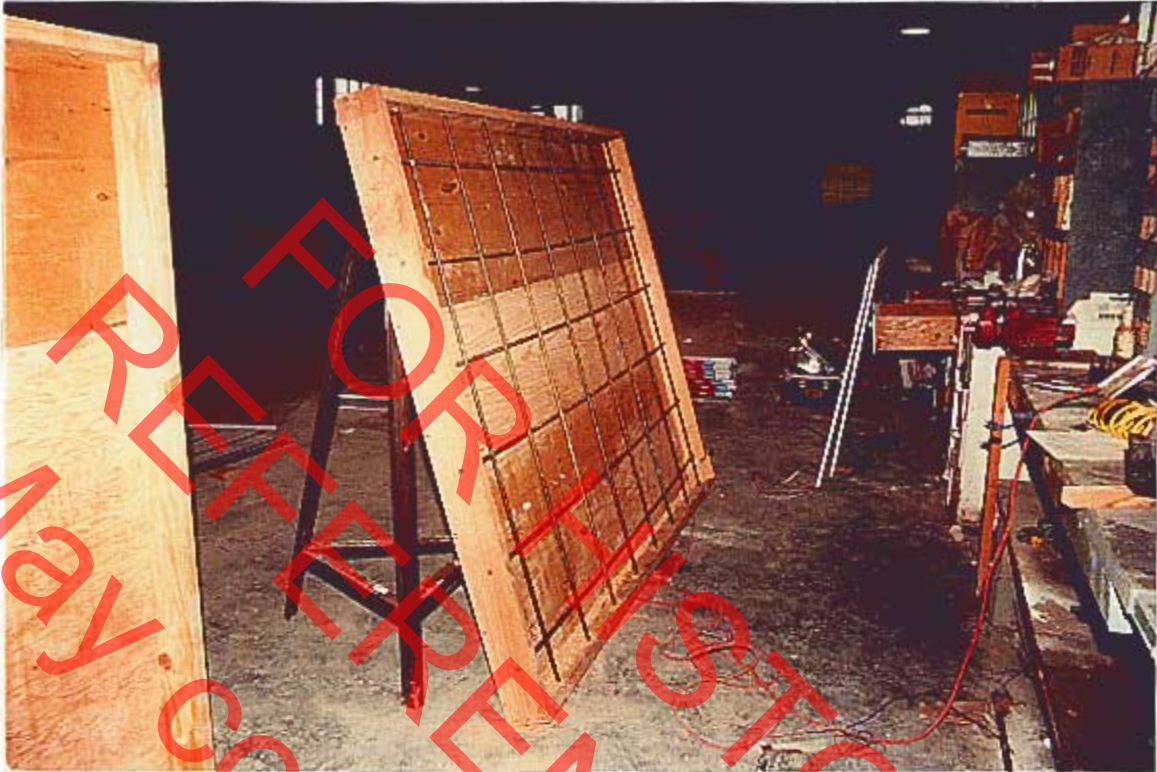
1. Rebar placed in form.

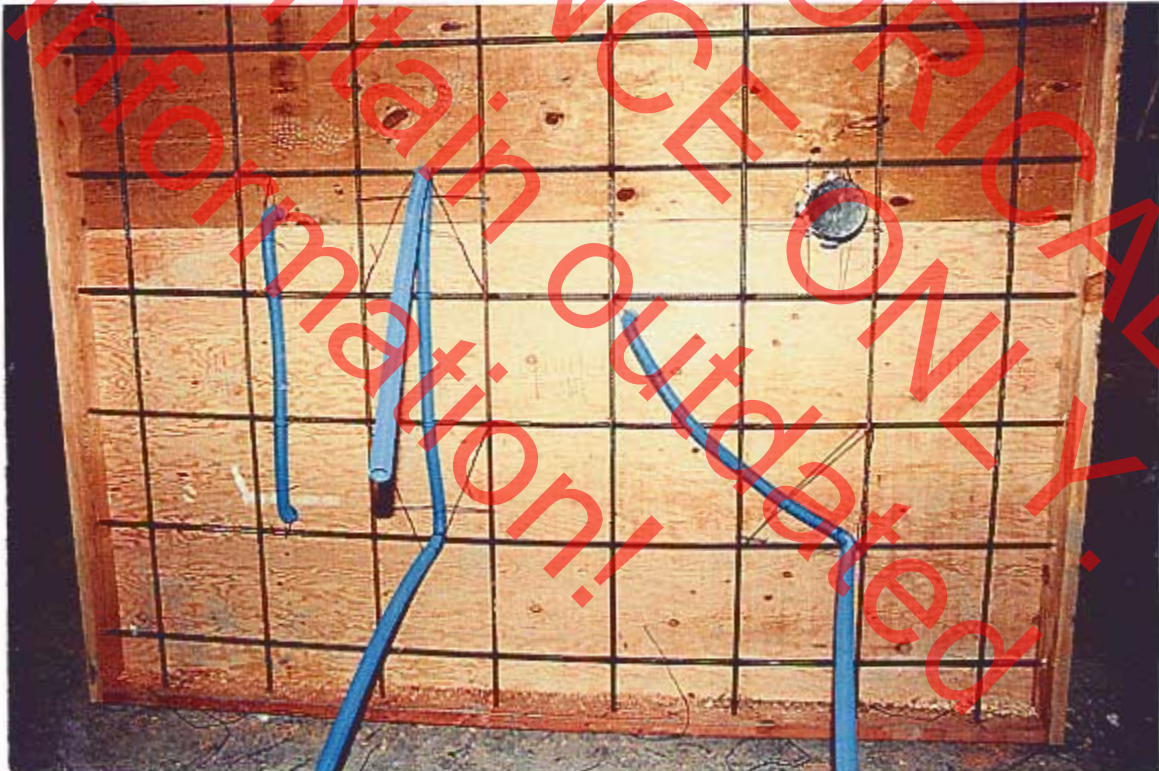
2. ENT installed.

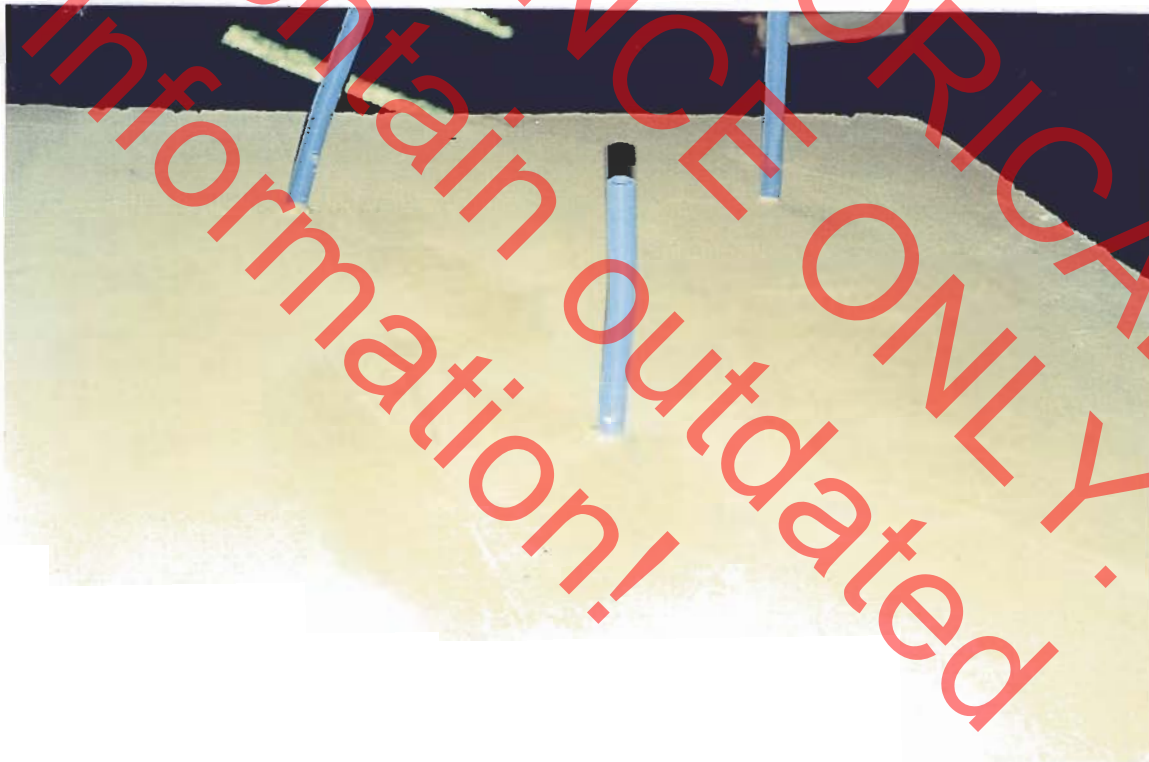
4. ENT on exposed (furnace) side of slab prior to test.

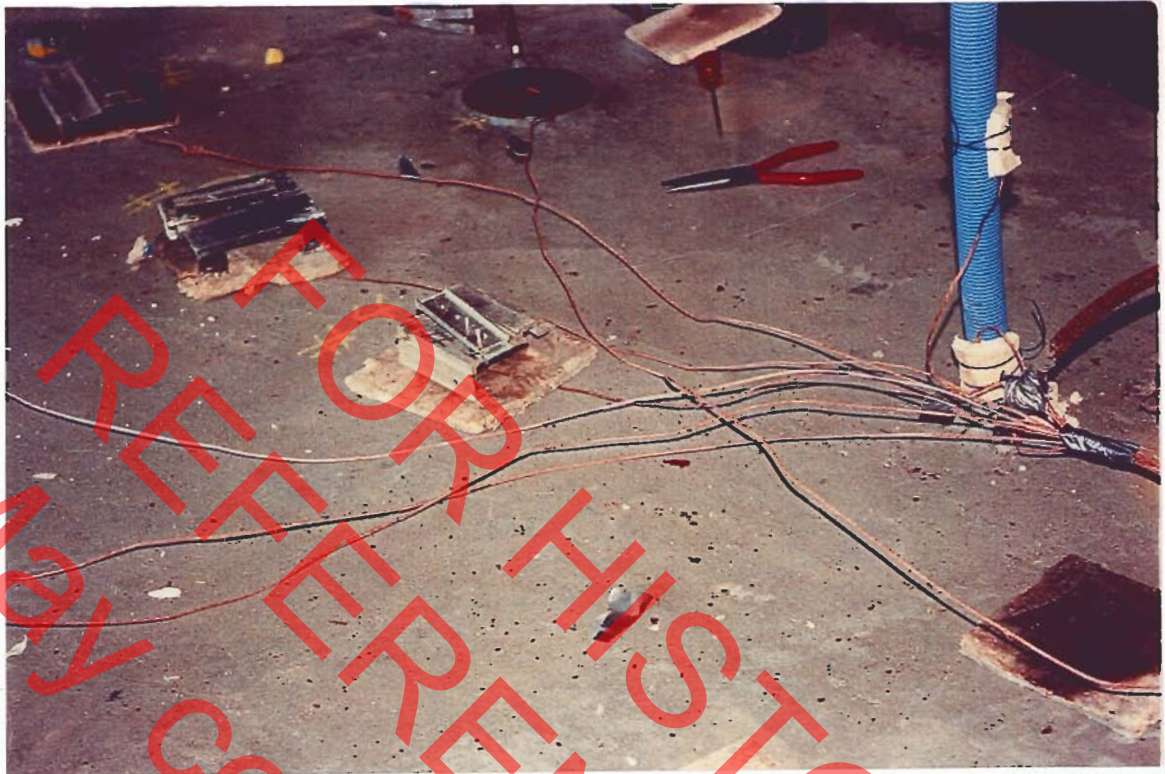
5. Thermocouple instrumentation, unexposed side.

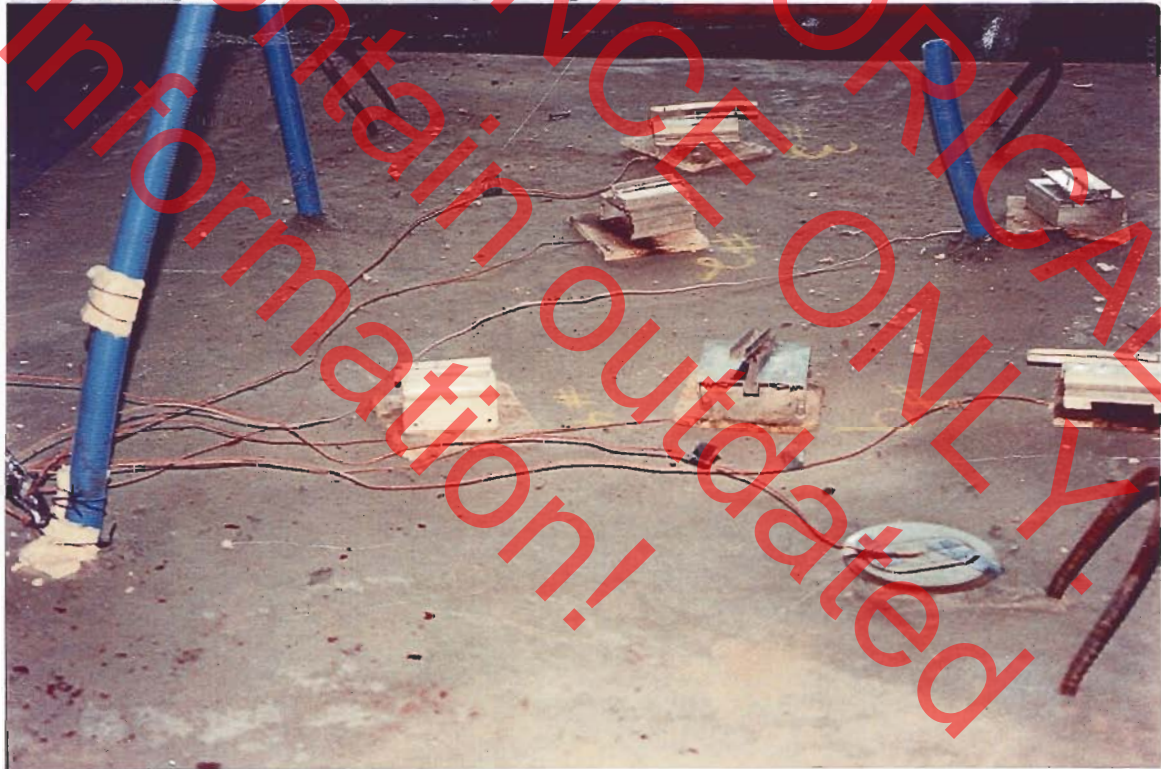
6. Ready to test. All thermocouples in place.

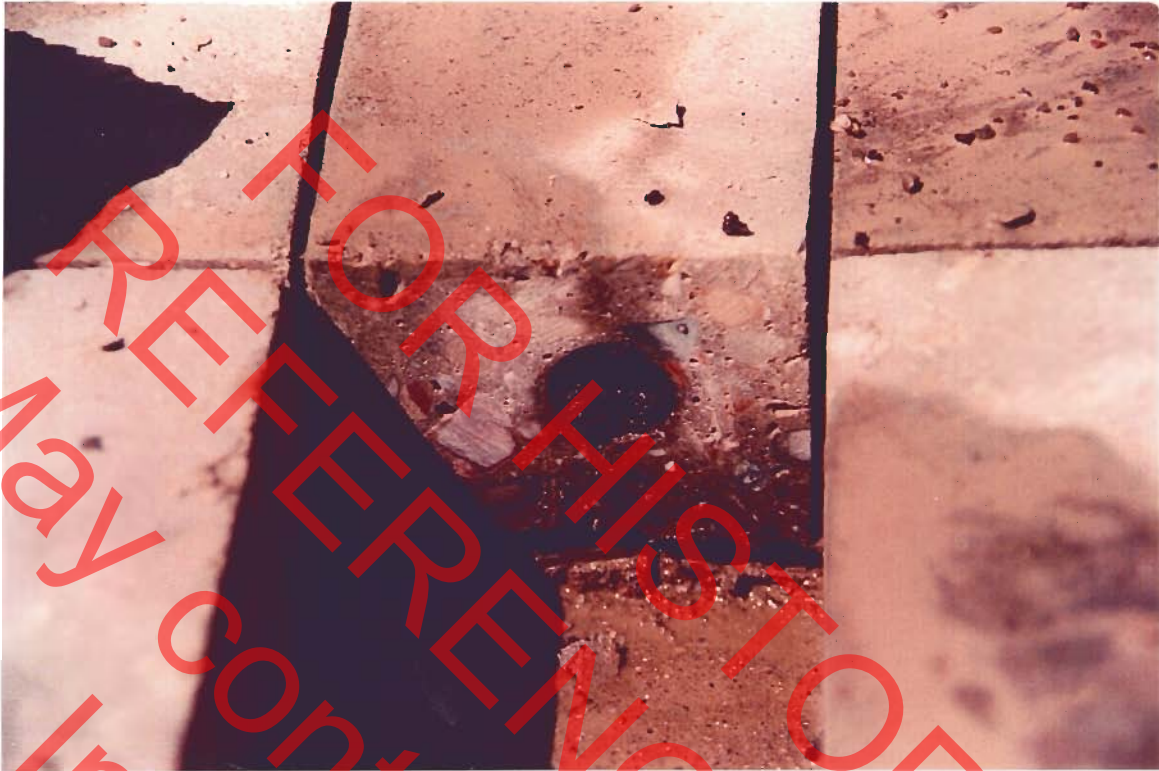
8. Post Test. Cross-section through ENT. Pyrolyzed residue of ENT in center.

Rather, the thermal degradation which occurs leads to development of a "char" in the slab.

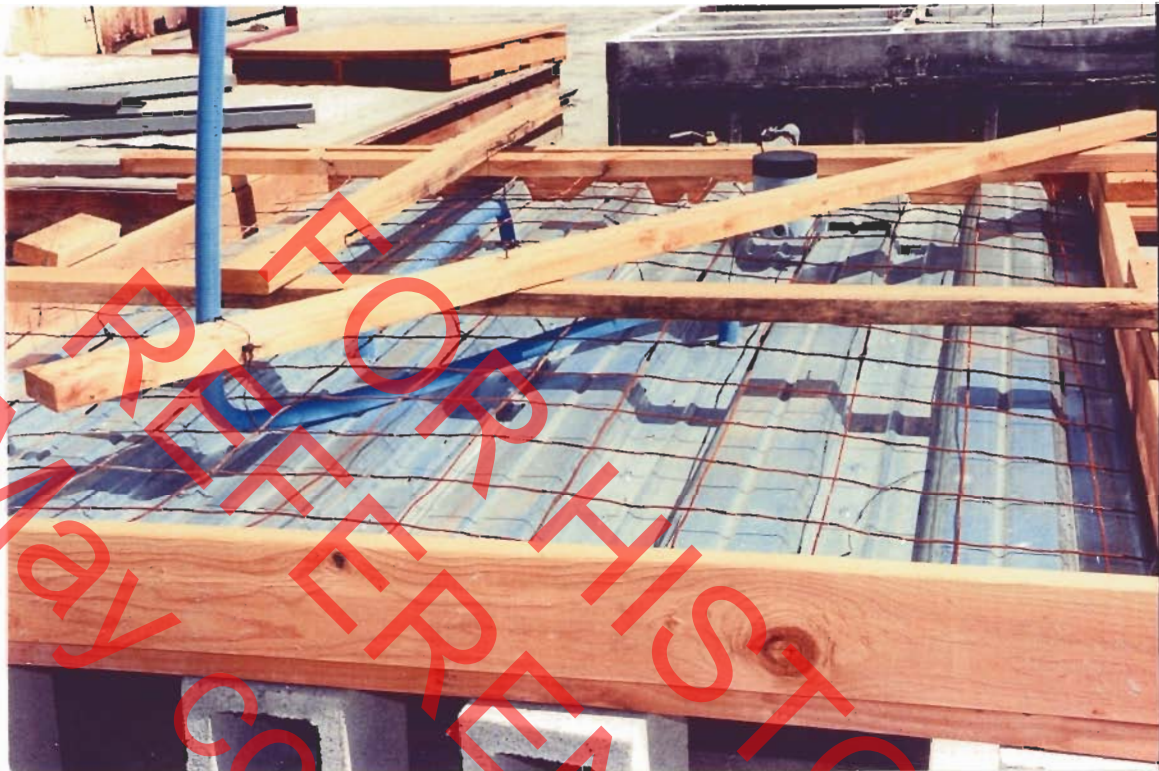
1. ENT installed ready for concrete application.

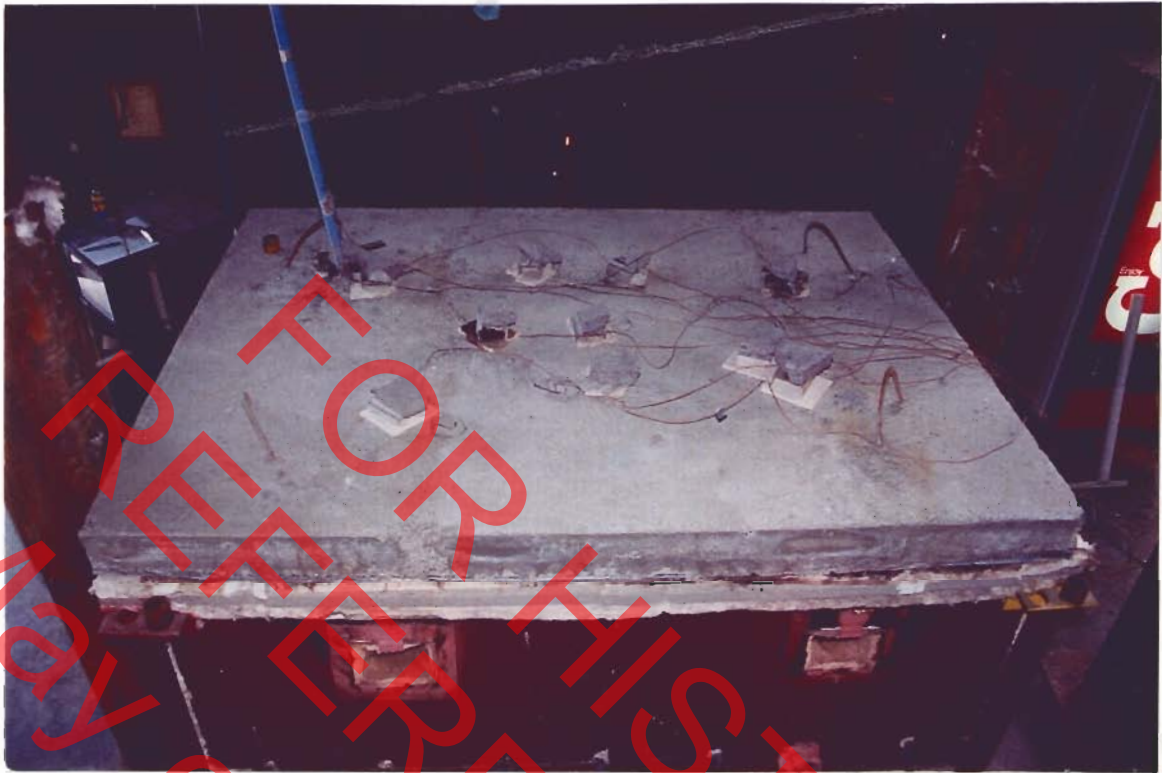
3. Lightweight slab test instrumented with thermocouples on furnace.

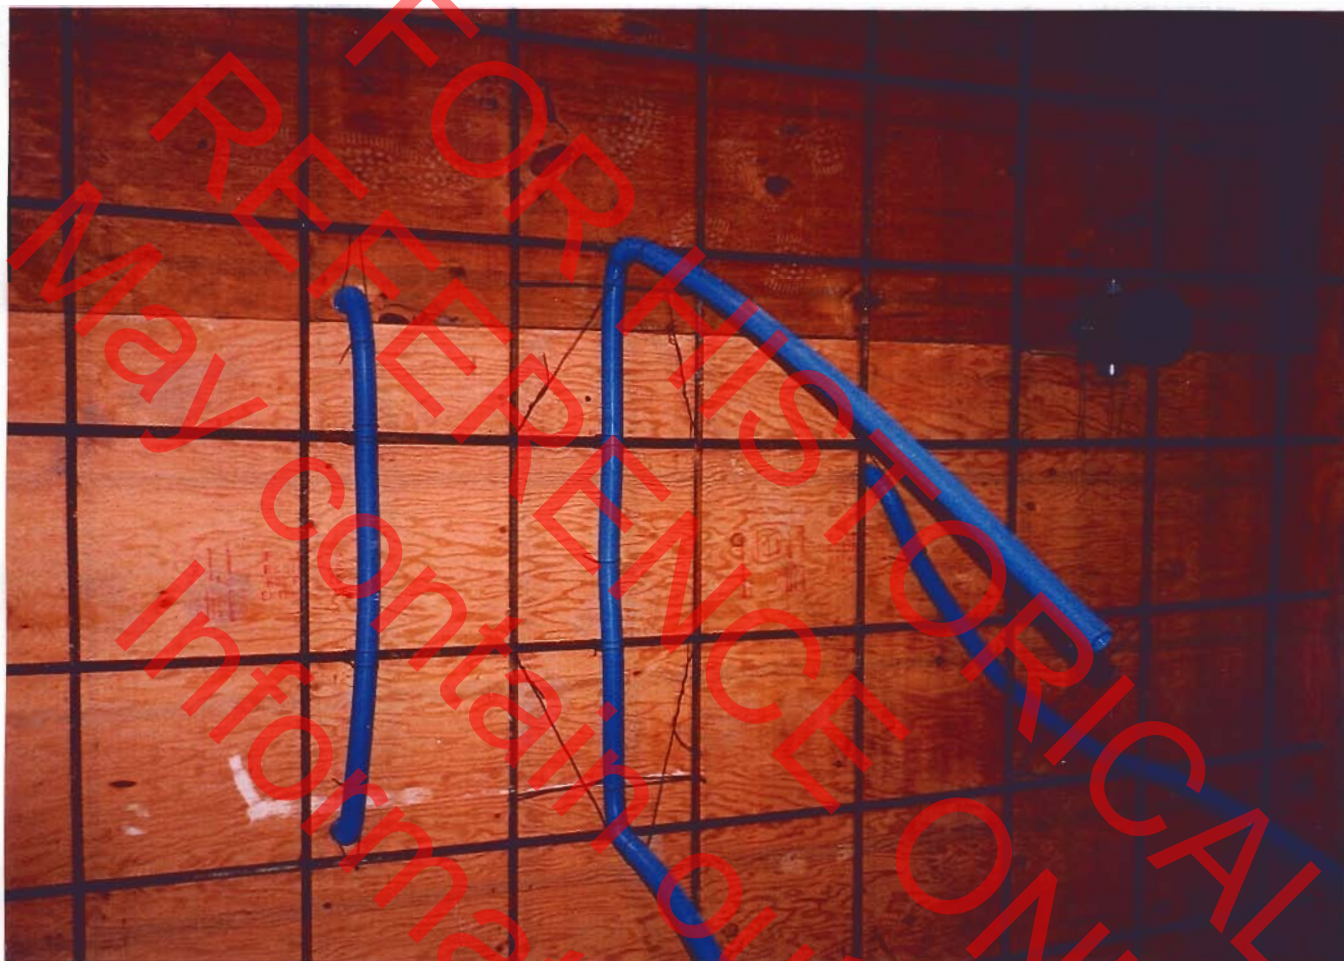
PHOTOGRAPH #1
THE WOOD FORM WITH CONDUIT AND REBAR INSTALLED

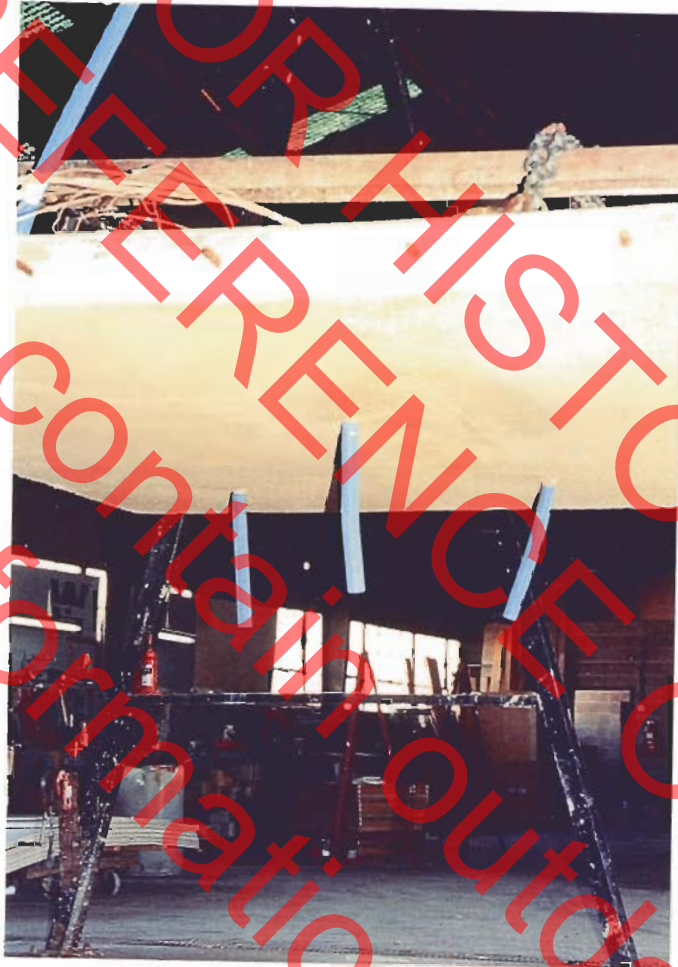
PHOTOGRAPH #2
A REVERSE SIDE VIEW OF THE FORM WITH CONDUIT INSTALLED

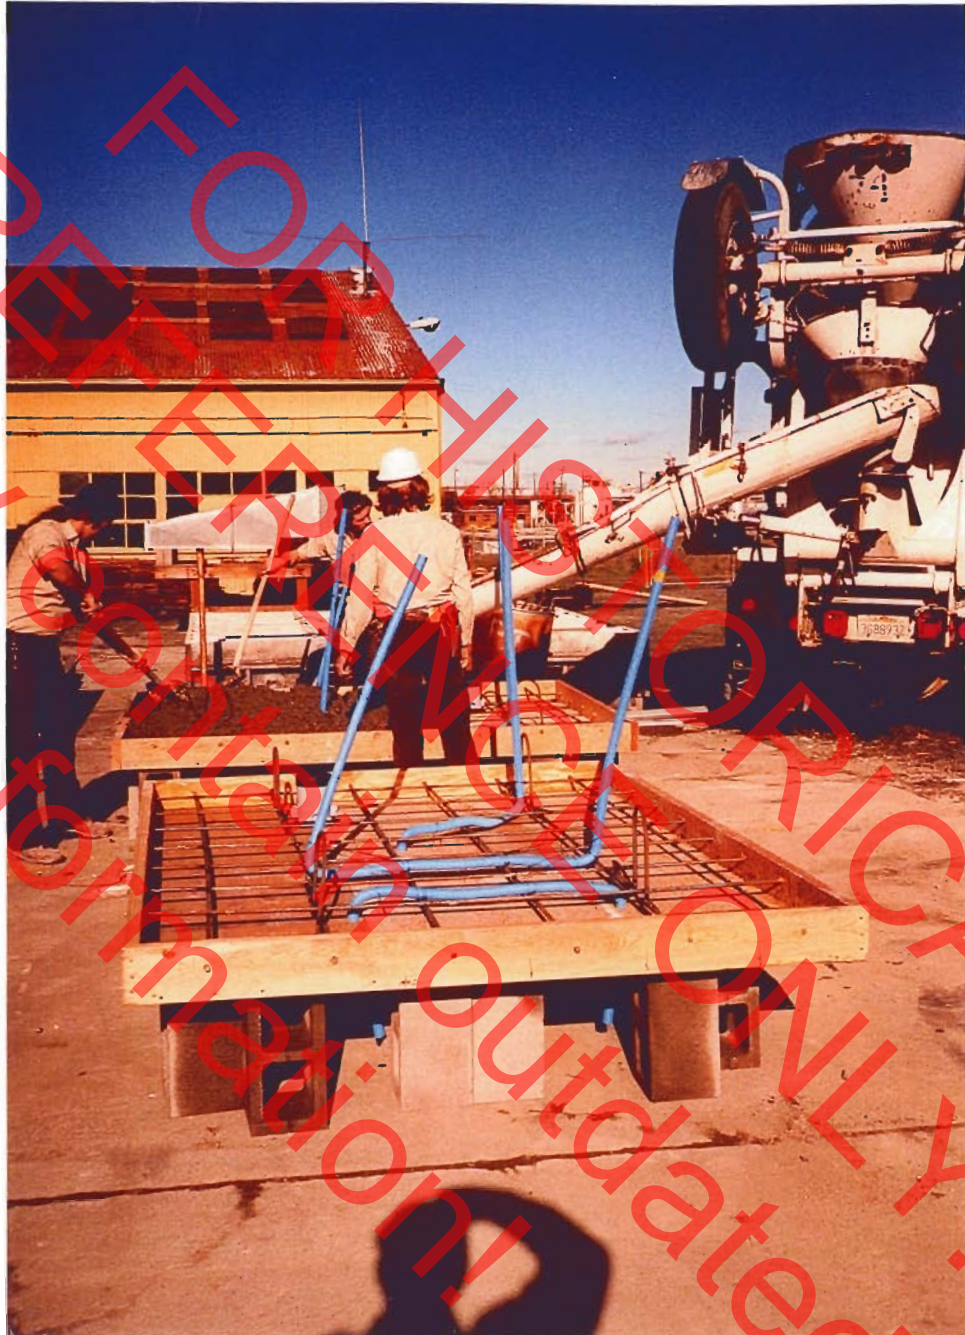
PHOTOGRAPH #3
A VIEW OF POURING CONCRETE IN THE FORMS

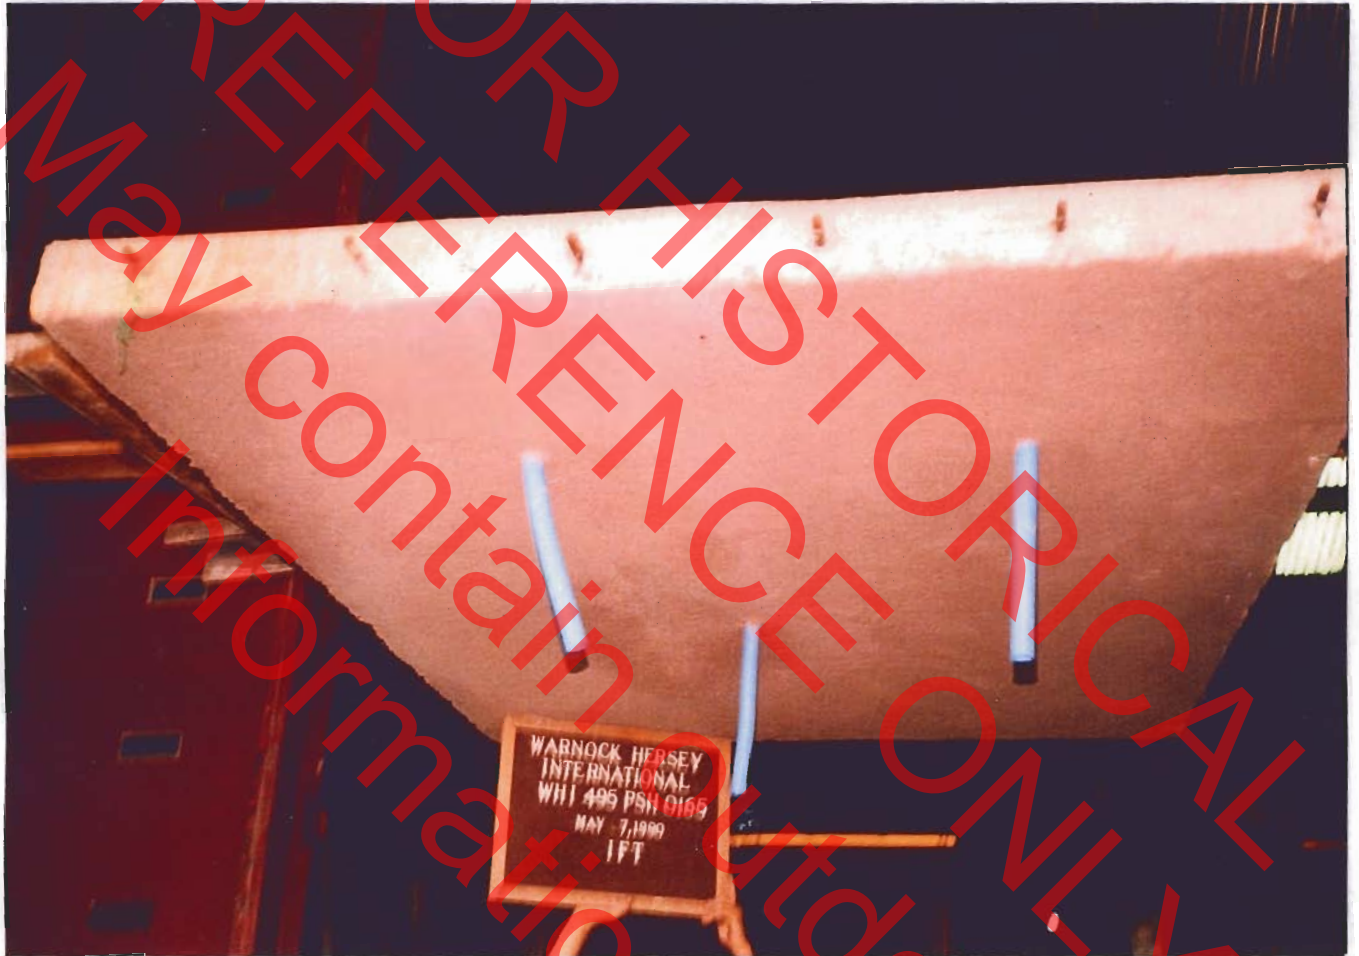
PHOTOGRAPH #4
THE EXPOSED SURFACE BEFORE THE START OF THE TEST

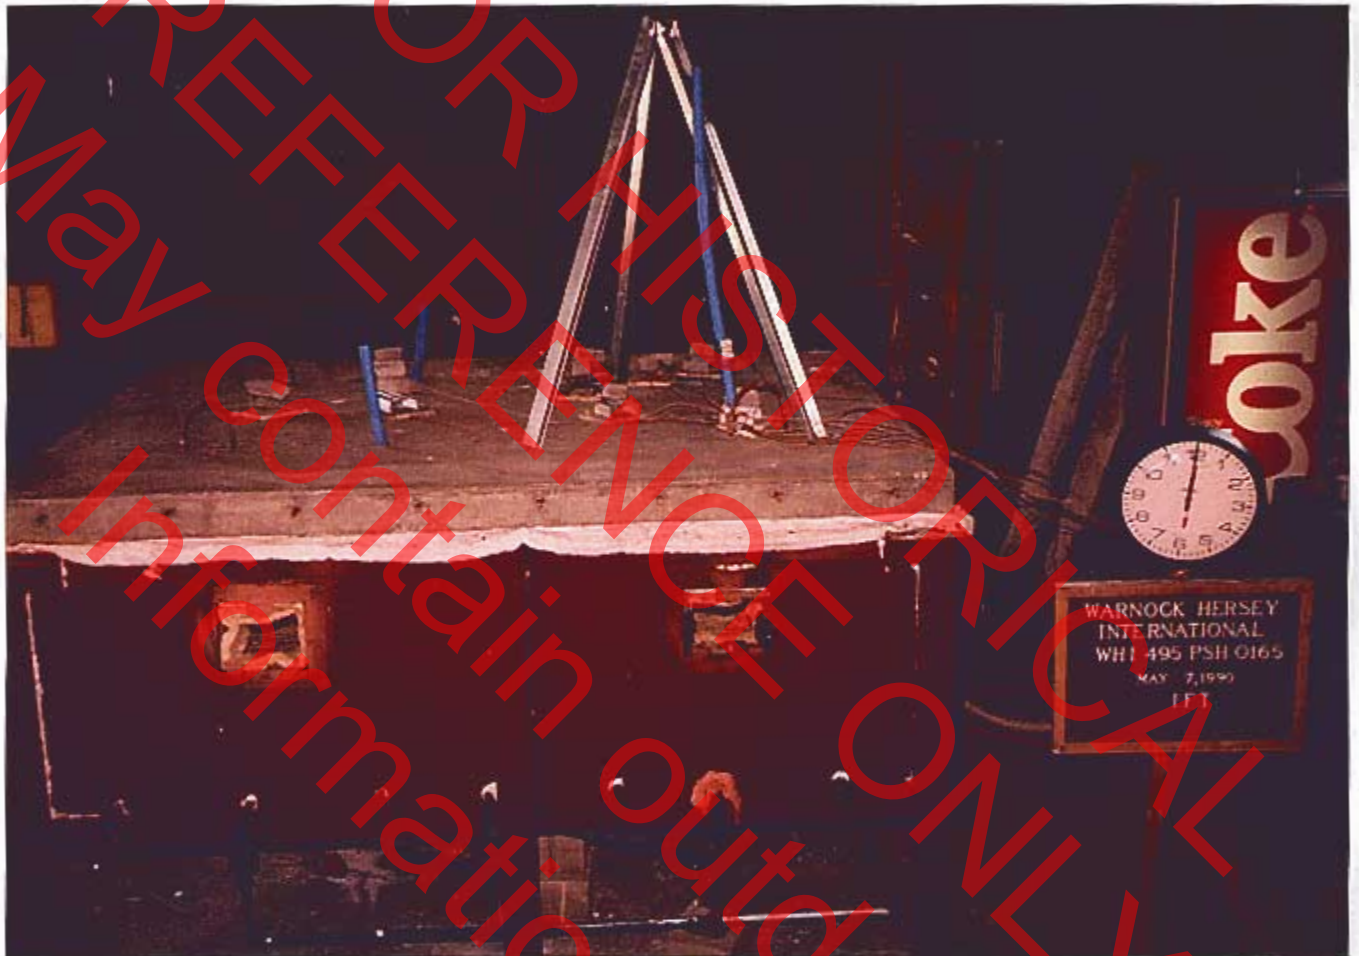
PHOTOGRAPH #5
THE UNEXPOSED SURFACE BEFORE THE START OF THE TEST

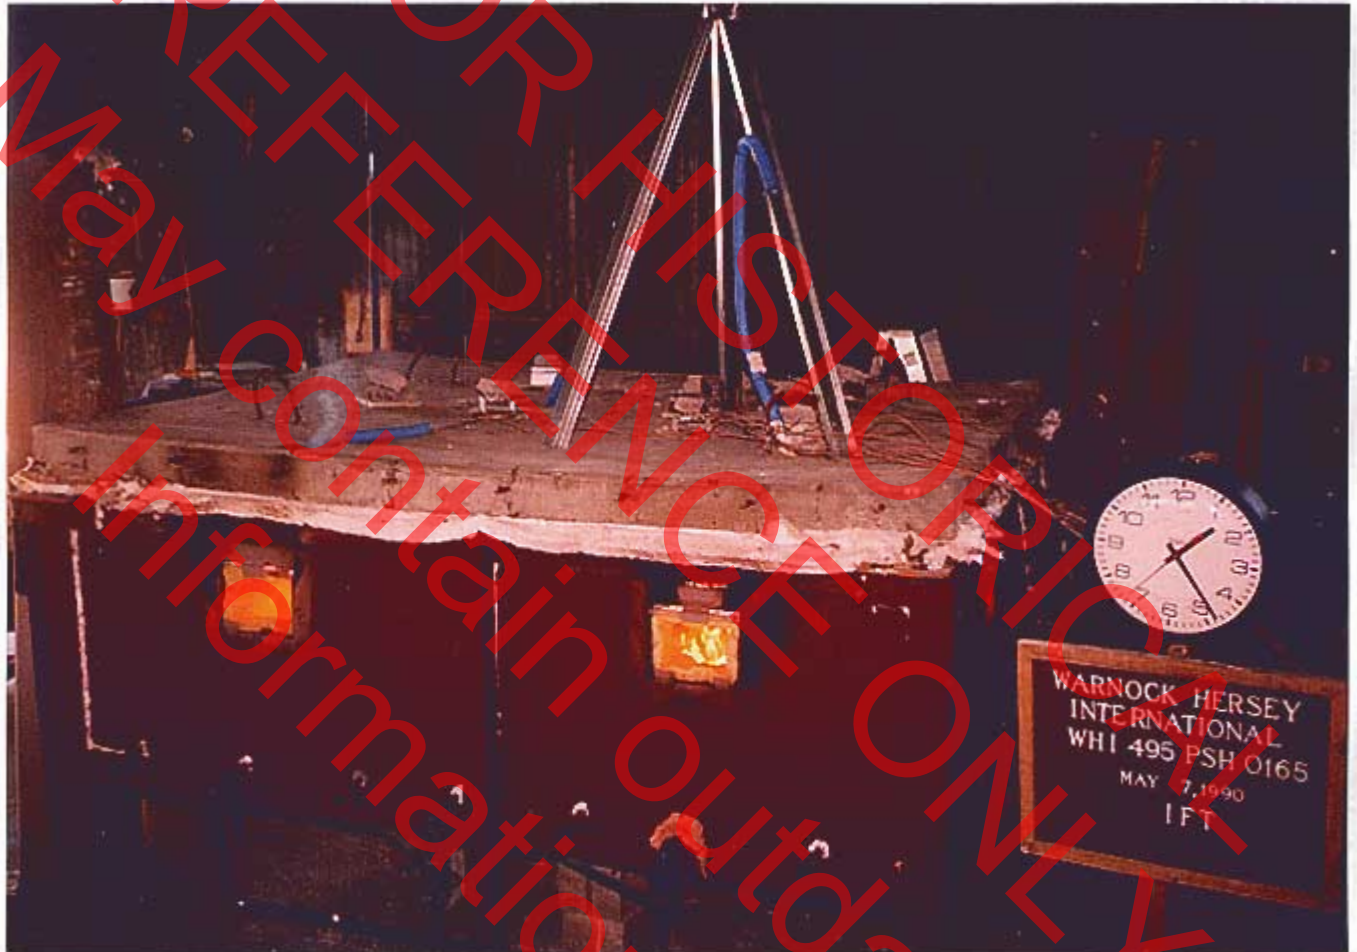
PHOTOGRAPH #6
THE UNEXPOSED SURFACE AT 83 MINUTES ELAPSED TIME

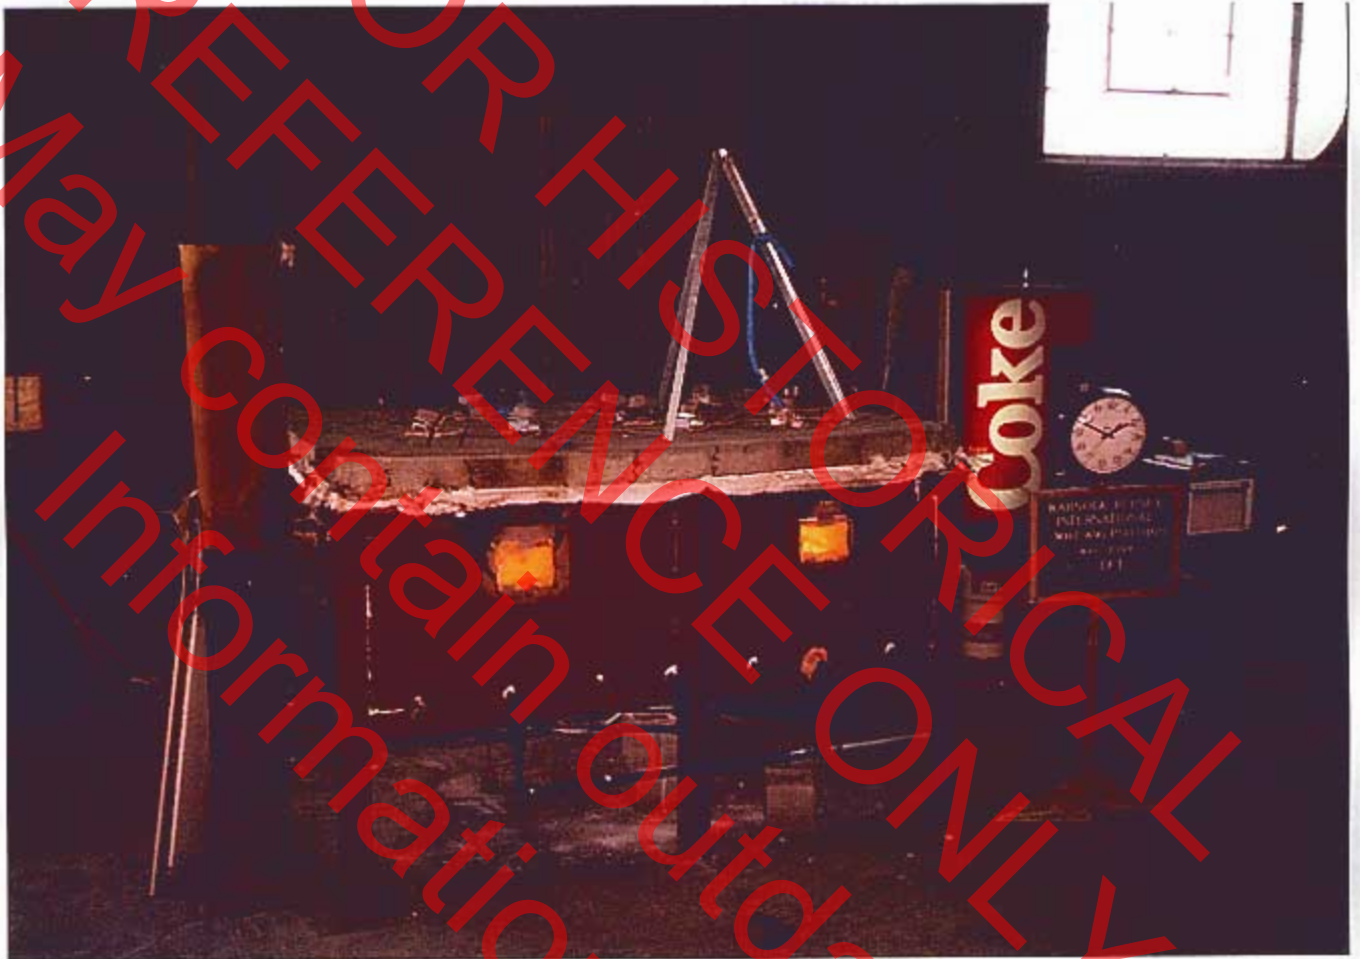
PHOTOGRAPH #7
THE UNEXPOSED SURFACE AT 108 MINUTES ELAPSED TIME

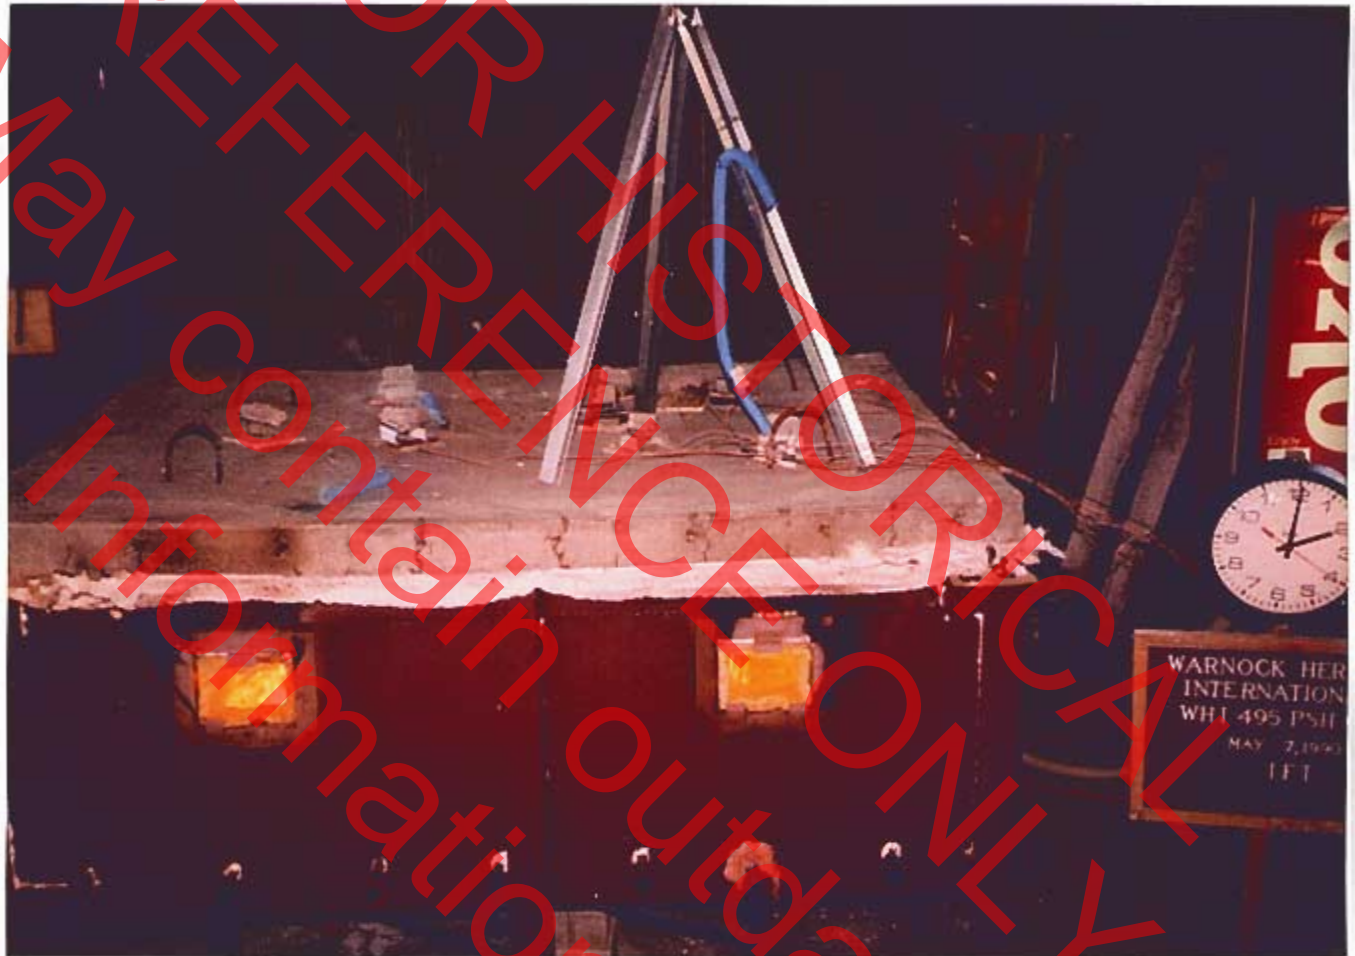
PHOTOGRAPH #8
THE UNEXPOSED SURFACE AT 120 MINUTES ELAPSED TIME

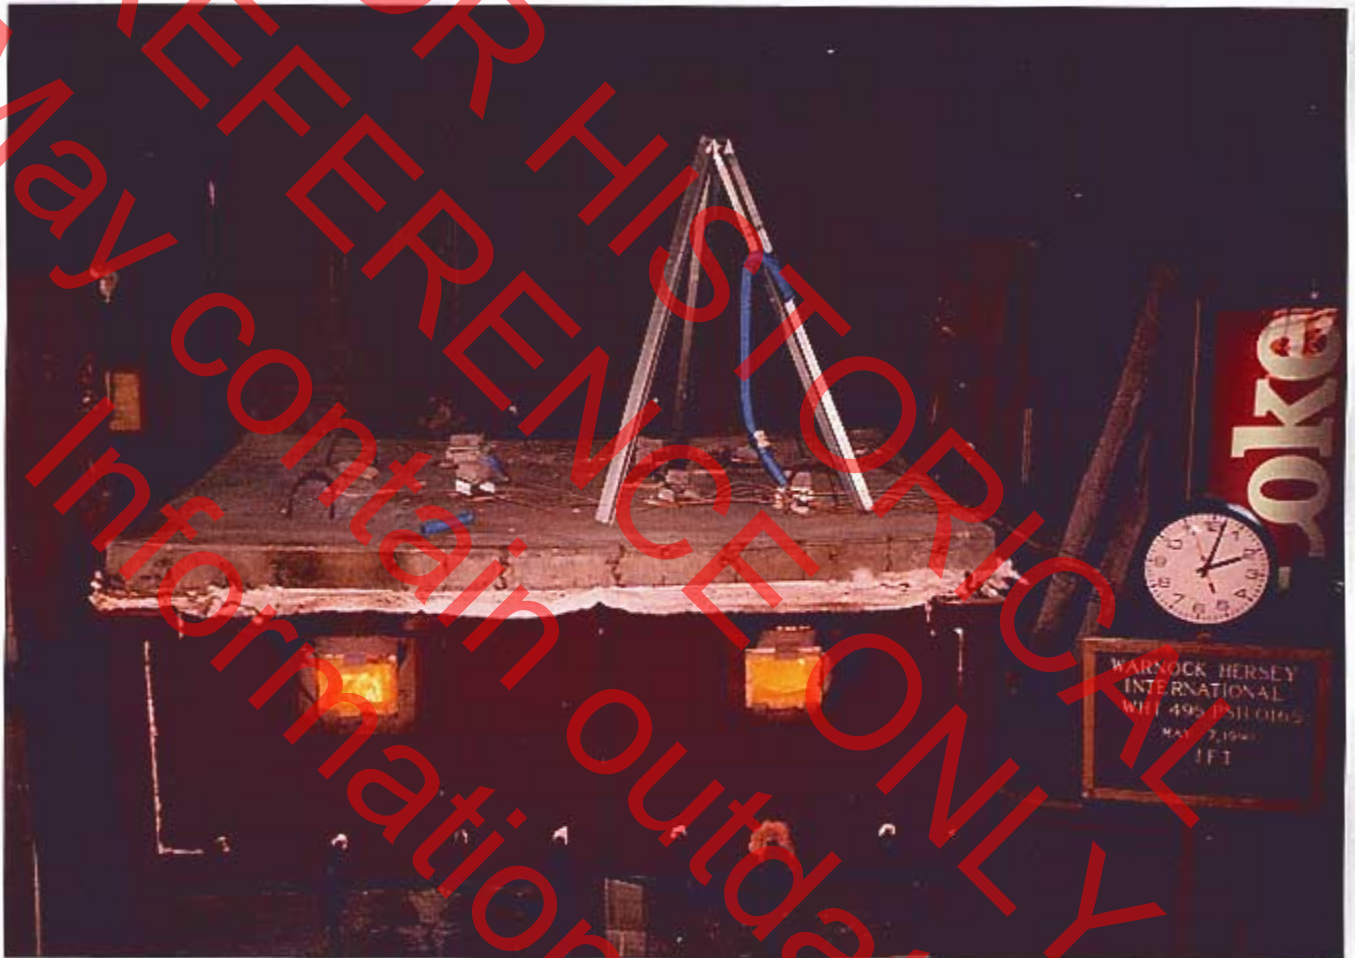
PHOTOGRAPH #9
THE UNEXPOSED SURFACE AT 122 MINUTES ELAPSED TIME

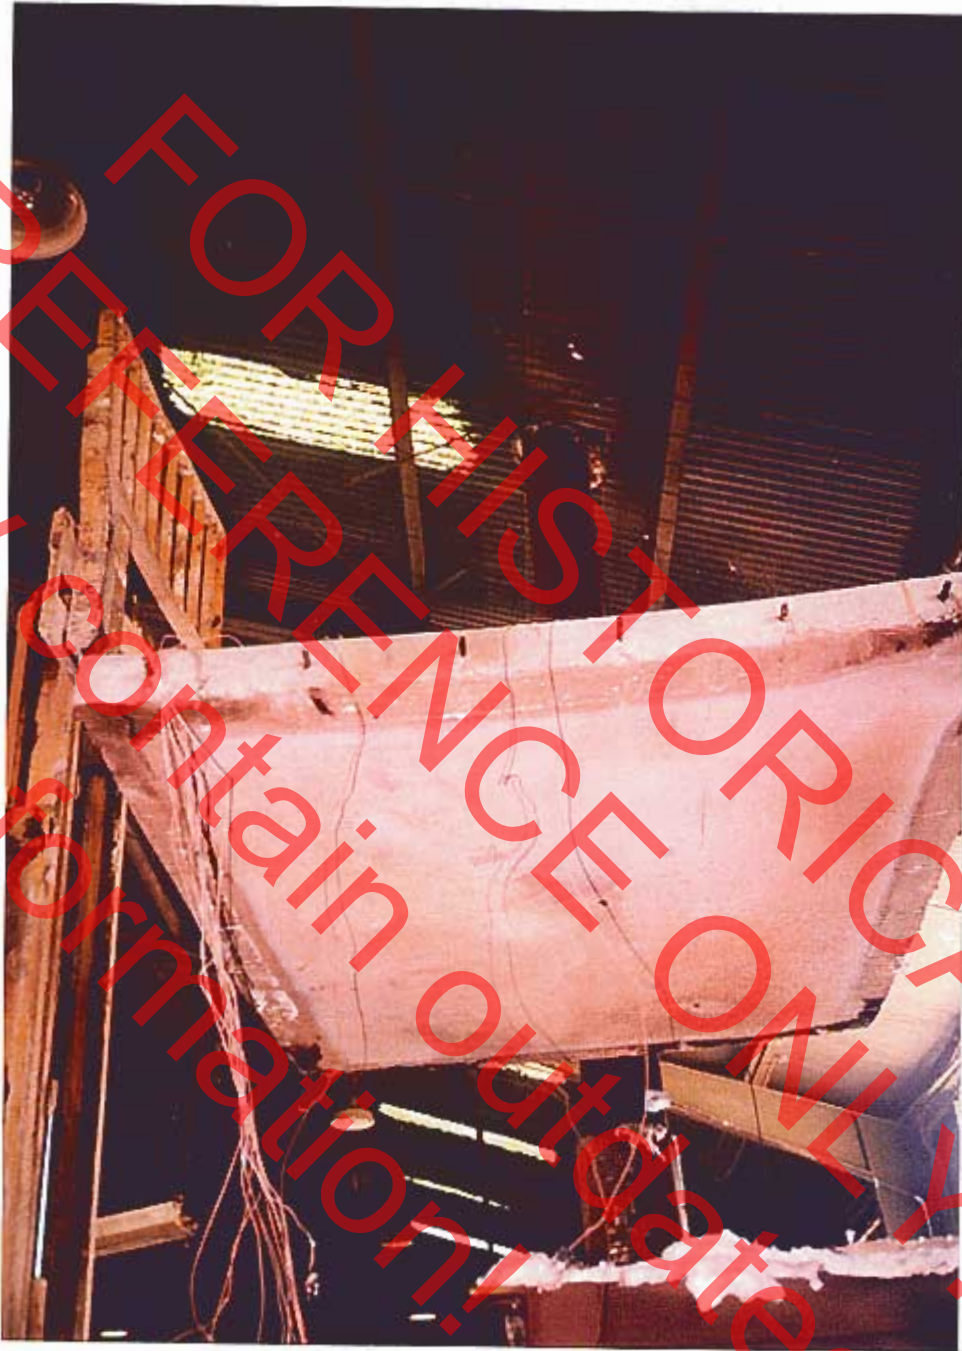
PHOTOGRAPH #10
THE EXPOSED SURFACE AFTER THE TEST WAS COMPLETED

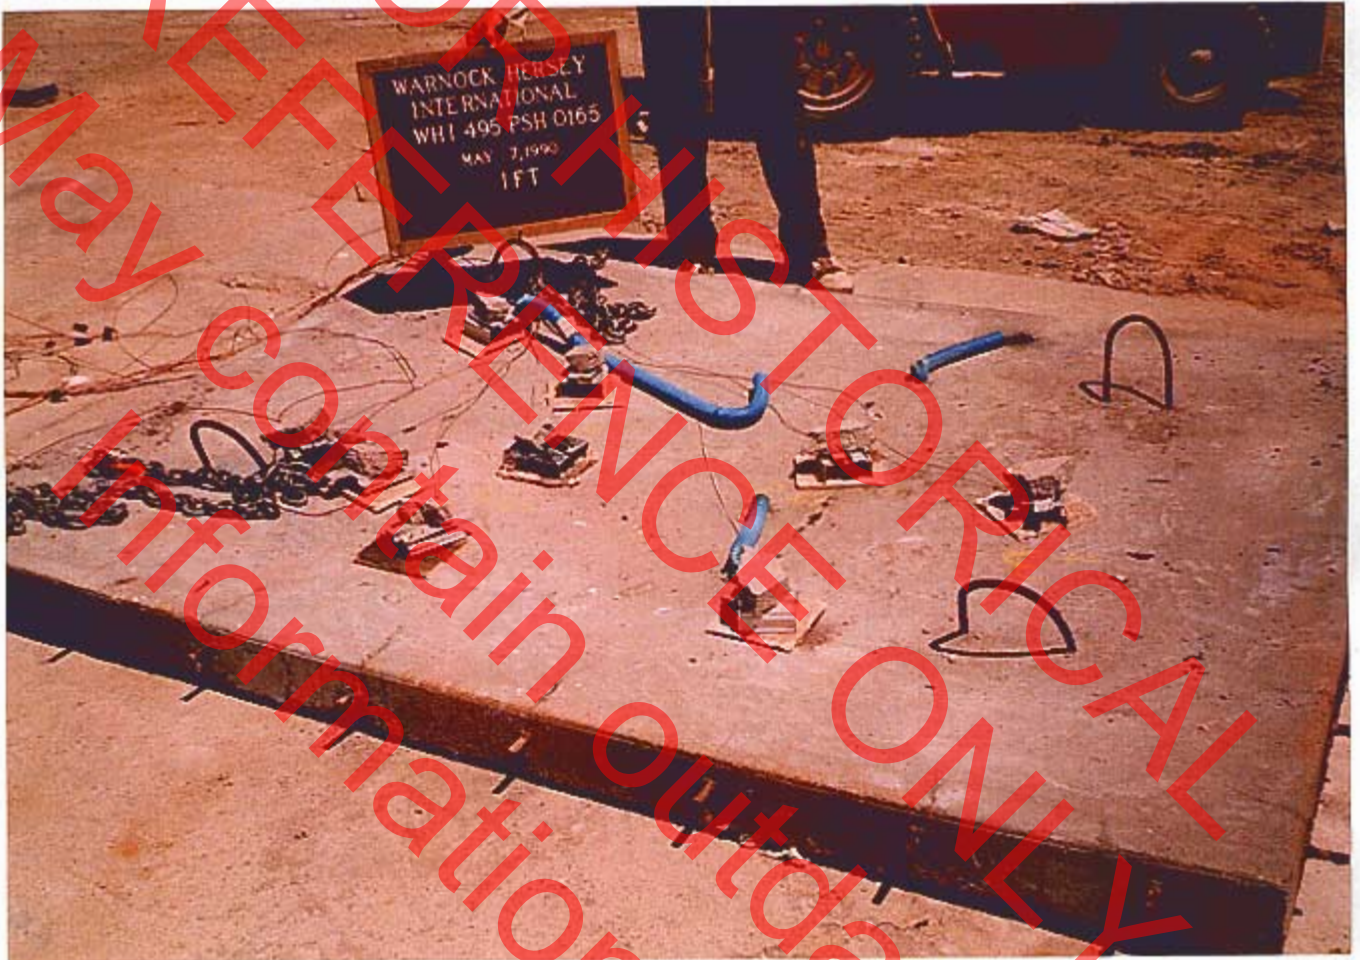
PHOTOGRAPH #11
THE UNEXPOSED SURFACE AFTER THE TEST WAS COMPLETED

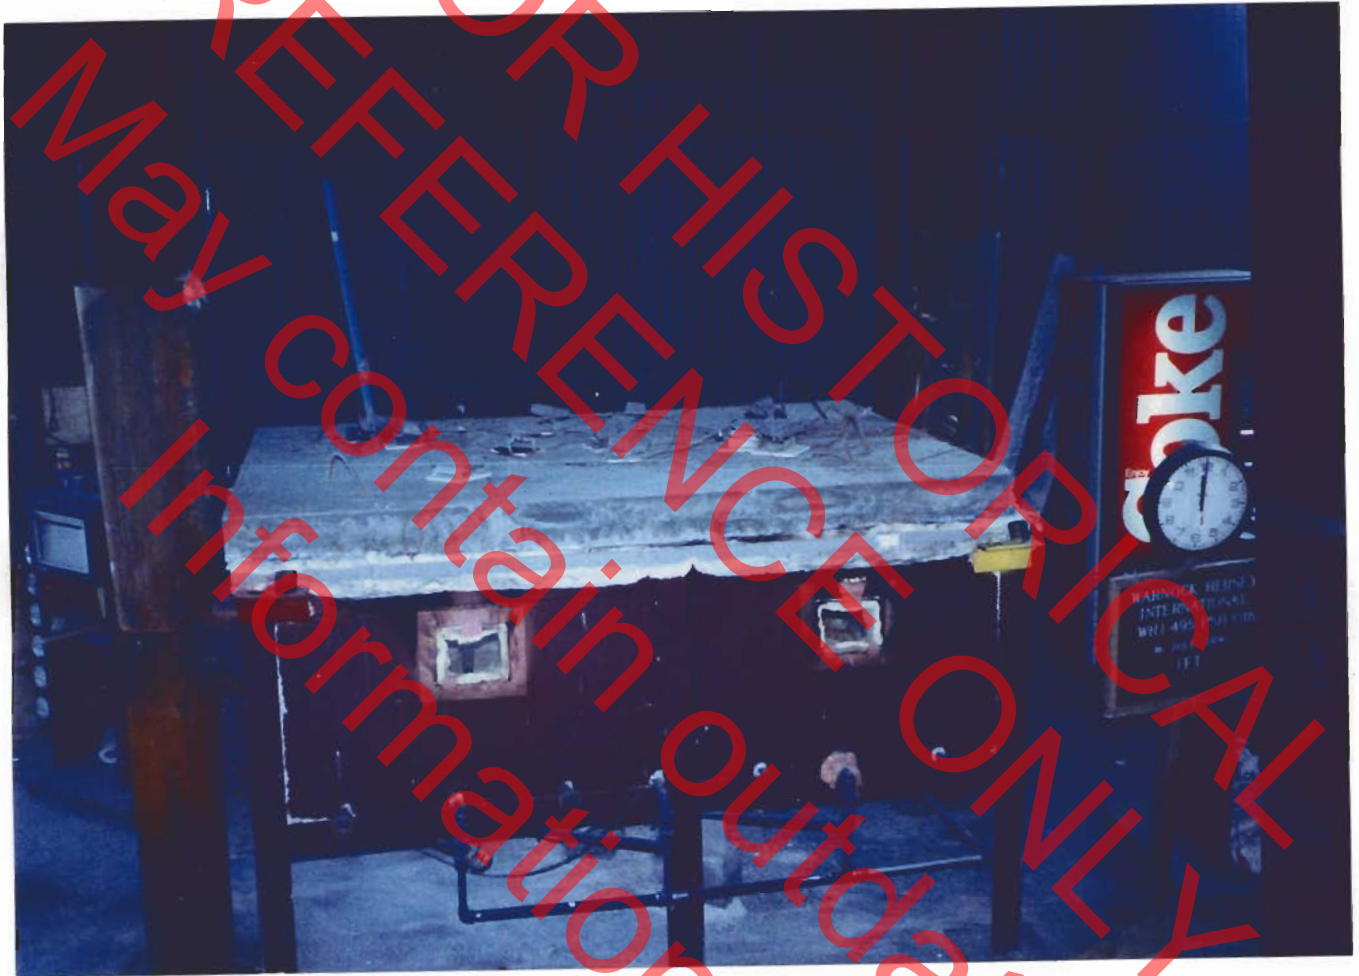
PHOTOGRAPH #1
THE UNEXPOSED SURFACE BEFORE THE START OF THE TEST
