**FIRE PERFORMANCE
OF
FIRE RESISTIVE CONCRETE SLAB ASSEMBLIES
WITH PVC RACEWAYS INSTALLED**

Ref: IFT 86-38D

REPORT OF THE PILOT SCALE FIRE ENDURANCE TEST
OF AN UNRESTRAINED 6' BY 8' BY 4-1/2" THICK,
REINFORCED CONCRETE SLAB WITHOUT AN APPLIED LOAD,
AND WITH 1" DIAMETER, PVC, FLEXIBLE, ENT CONDUIT RUNS

FILE NUMBER: WHI-495-PSH-0165
WORK ORDER NUMBER: 50611-C7-030320
DATE TESTED: MAY 7, 1990

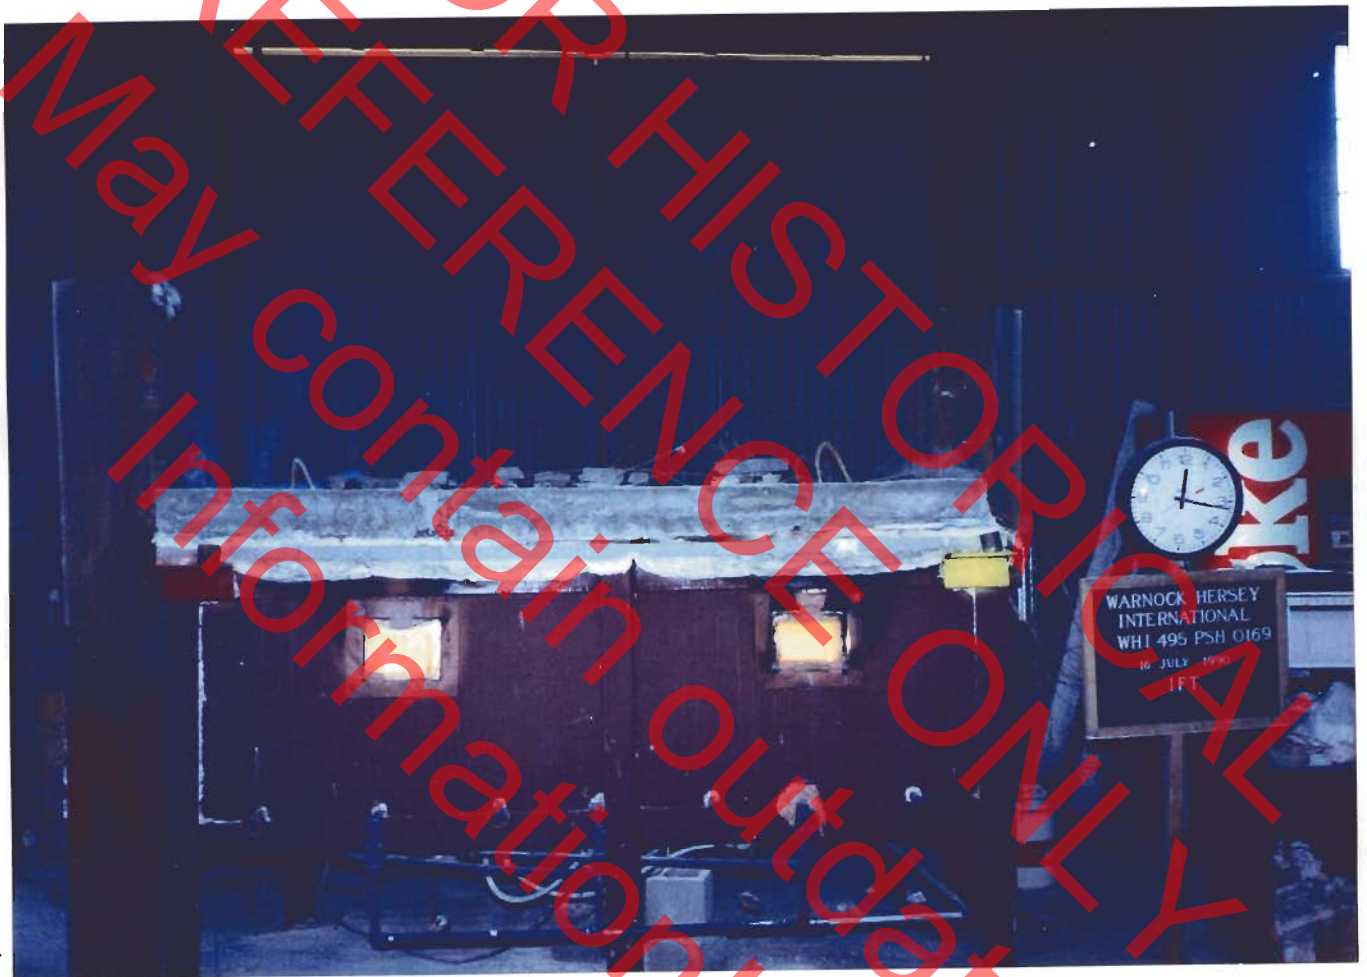
PHOTOGRAPH #2
THE UNEXPOSED SURFACE AT 16 MINUTES ELAPSED TIME

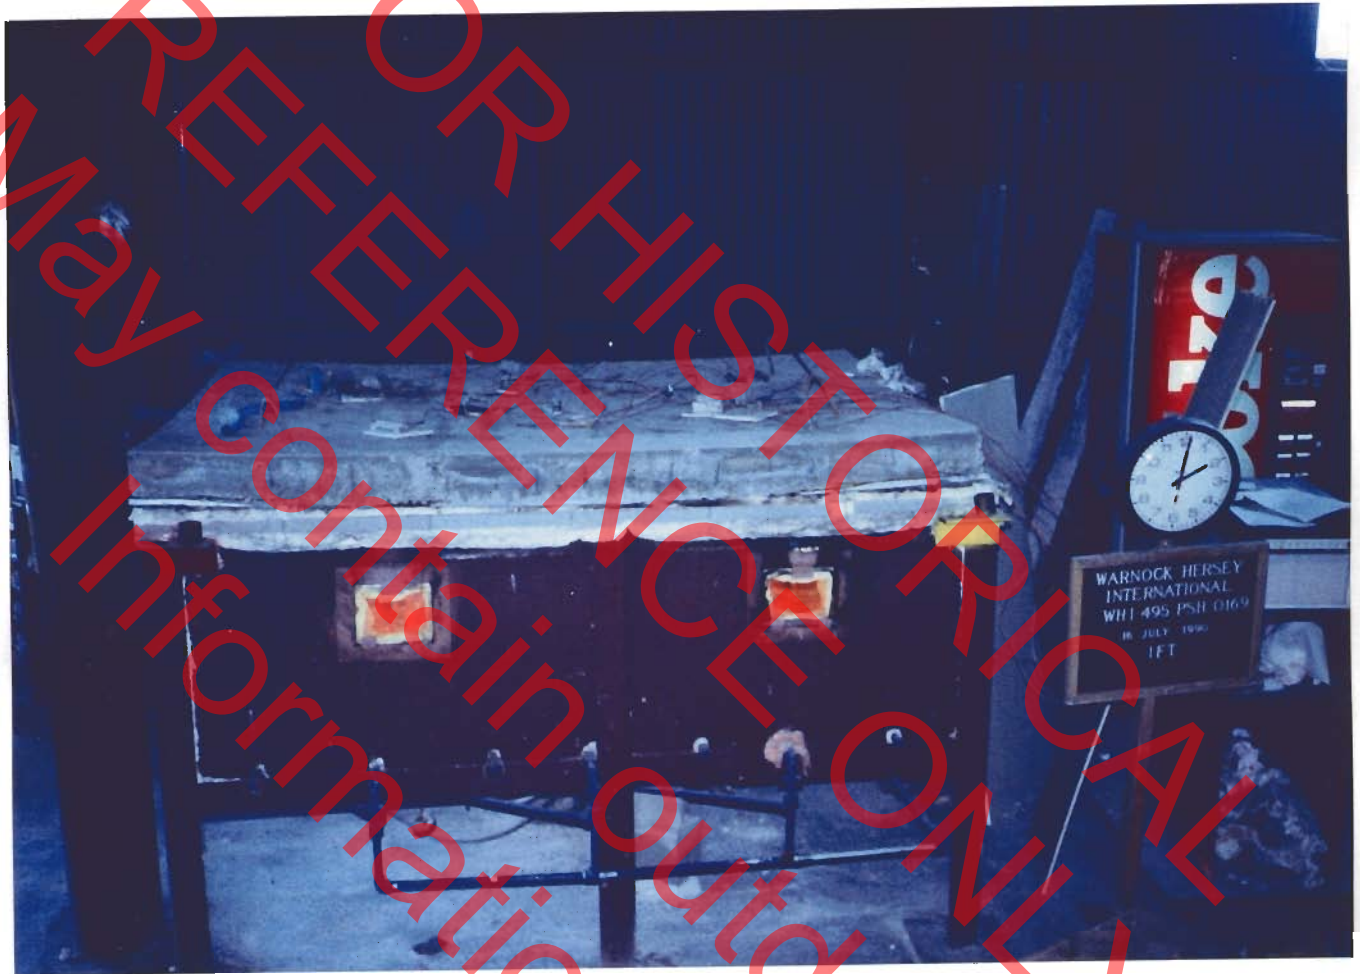
PHOTOGRAPH #3
THE UNEXPOSED SURFACE AT 121 MINUTES ELAPSED TIME

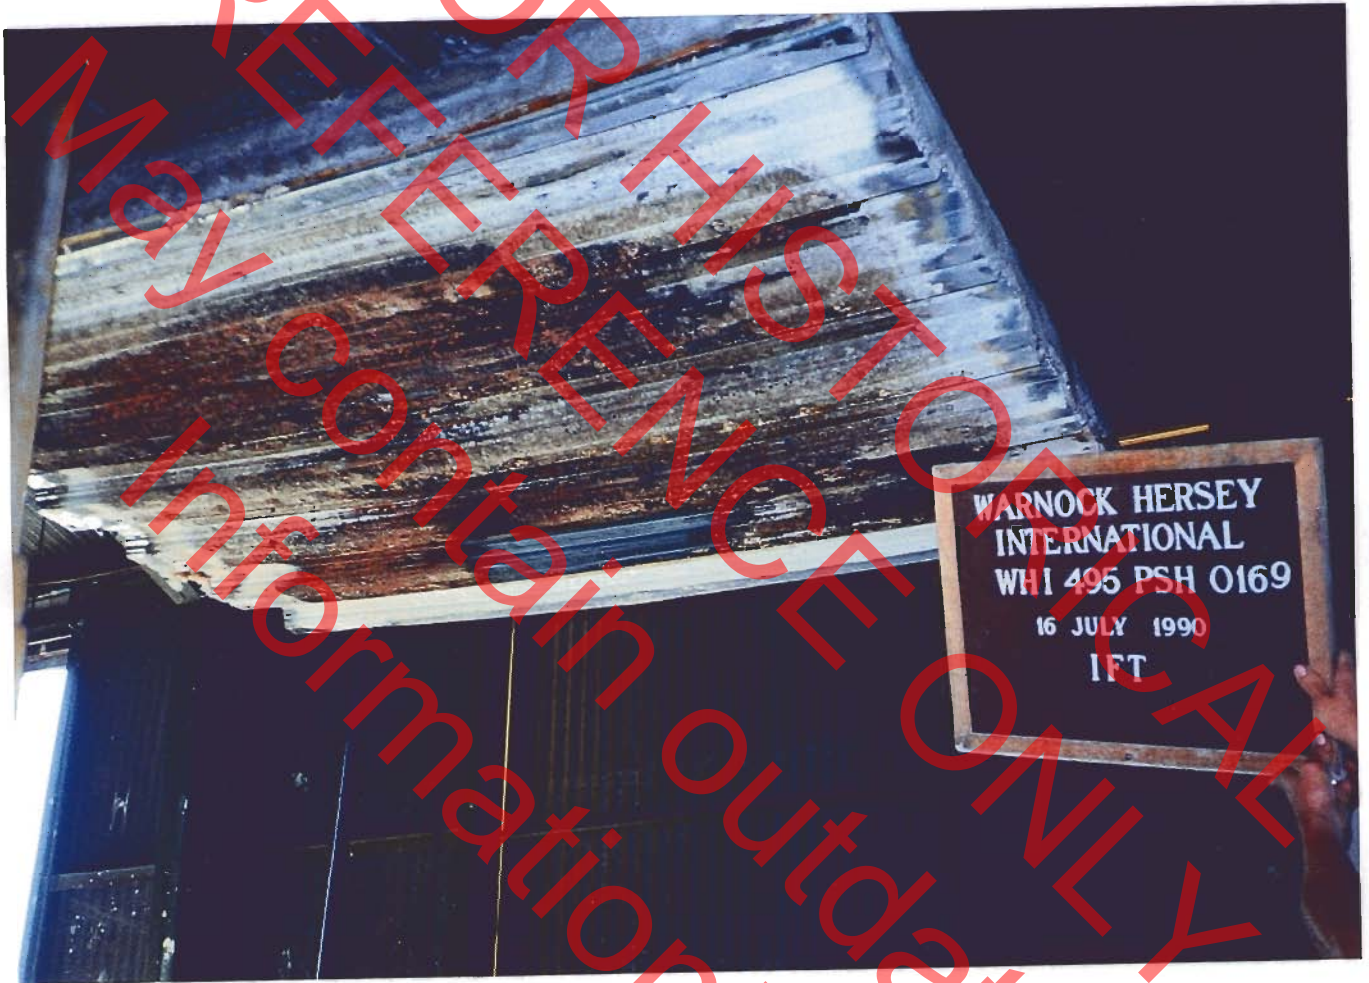
PHOTOGRAPH #4

THE EXPOSED FACE AFTER THE FIRE ENDURANCE TEST WAS COMPLETED
