TRIAL BY FIRE.

When fire breaks out every second counts. Recent fire tests, conducted by an independent testing laboratory, show that Electrical Non-metallic Tubing (ENT) and PVC Conduit protect electrical circuits longer than Electrical Metallic Tubing (EMT) and Intermediate Metallic (IMC) Conduit.

Test objective—Test No. 1

Test objective—Test No. 2

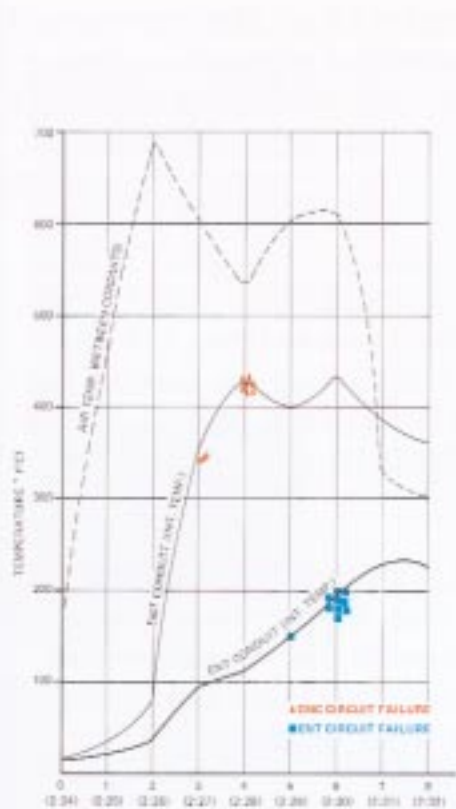
TEST NO. 1

TIME VS. TEMPERATURE CURVES (SEE CURVES FOR IDENTIFICATION)

Temperature curves plotted from the test data show that after two minutes of exposure to the flames, the internal temperature of the metallic conduit far exceeds the internal temperature of the non-metallic conduit which does not conduct heat as readily.

* Conduit temperatures are measured internally by IC thermocouples placed inside the individual test sections. Air temperatures are measured by IC thermocouples outside and equally spaced between the conduit test sections. (Thermocouple and thermocouple shield can be seen in photos between conduits.)

As could be expected, when the air temperatures in both test rose to in excess of 600°C, the internal temperatures of the test specimens, as measured by their respective thermocouples, also rose sharply. The slope of both the EMT and the IMC curves, however, were greater than the slopes of their non-metallic counterparts

and the internal temperatures of the metallic test specimens, in both tests, were considerably higher than the temperatures measured in the non-metallic test specimens (see time vs. temperature curves Test No. 1 and Test No. 2).

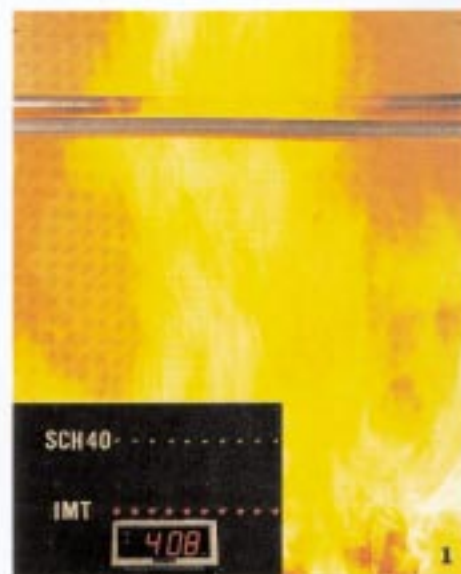
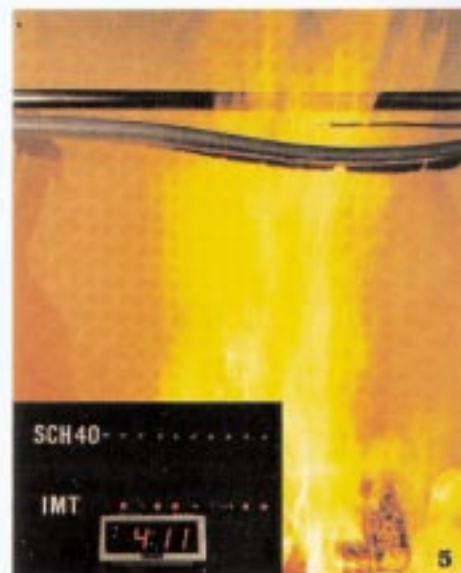
Test No. 2 Schedule 40 PVC vs. IMC

As shown by panel 1, all 10 circuits (red indicator lights) in the IMC conduit and all 10 circuits (green indicator lights) in the schedule 40 PVC conduit were functional at 4:08 one minute into the test.

As shown by panel 2, at 4:09, 2 minutes into the test the first circuit failed in the IMC conduit. The second circuit in the IMC conduit failed at 4:10 (see panel 3) followed by two additional circuit failures in the third minute of the test (see panel 4). At 4:11 (see panels 5, 6, and 7) the remaining circuits in the IMC conduit failed. **Significantly, not a single circuit in the schedule 40 PVC conduit had failed up to that point.**

At 4:14, seven minutes into the test, the first circuit in the schedule 40 PVC failed, quickly followed by a second circuit failure (panel 9), followed by five circuit failures at 4:15 (panels 10 and 11). Two of the remaining three circuits in the schedule 40 PVC failed at 4:18 (see panels 12 and 13). The last remaining circuit in the schedule 40 PVC conduit (panel 14) remained illuminated when the test was terminated at 4:24.
