# TRIAL BY FIRE.

**When fire breaks out every second counts. Recent fire tests, conducted by an independent testing laboratory, show that Electrical Non-metallic Tubing (ENT) and PVC Conduit protect electrical circuits longer than Electrical Metallic Tubing (EMT) and Intermediate Metallic (IMC) Conduit.**

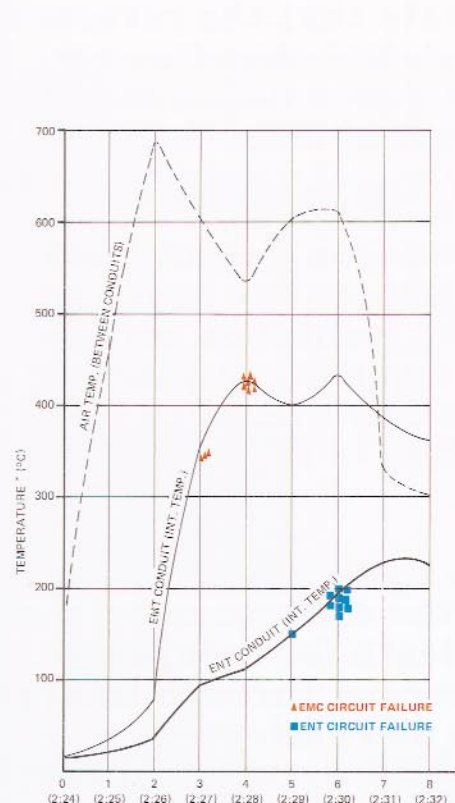
**TEST NO. 1**  
**TIME VS. TEMPERATURE CURVES (SEE CURVES FOR IDENTIFICATION)**

Temperature curves plotted from the test data show that after two minutes of exposure to the flames, the internal temperature of the metallic conduit far exceeds the internal temperature of the non-metallic conduit which does not conduct heat as readily.

\* Conduit temperatures are measured internally by IC thermocouples placed inside the individual test sections. Air temperatures are measured by IC thermocouples outside and equally spaced between the conduit test sections. (Thermocouple and thermocouple shield can be seen in photos between conduits.)

As could be expected, when the air temperatures in both test rose to in excess of 600°C, the internal temperatures of the test specimens, as measured by their respective thermocouples, also rose sharply. The slope of both the EMT and the IMC curves, however, were greater than the slopes of their non-metallic counterparts

and the internal temperatures of the metallic test specimens, in both tests, were considerably higher than the temperatures measured in the non-metallic test specimens (see time vs. temperature curves Test No. 1 and Test No. 2).

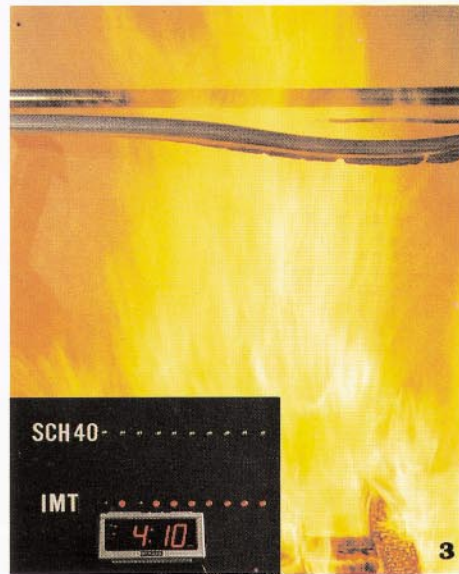
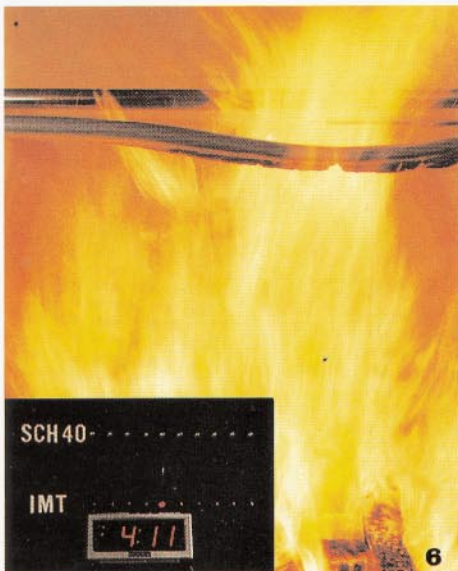
### Test No. 2 Schedule 40 PVC vs. IMC

As shown by panel 1, all 10 circuits (red indicator lights) in the IMC conduit and all 10 circuits (green indicator lights) in the schedule 40 PVC conduit were functional at 4:08 one minute into the test.

As shown by panel 2, at 4:09, 2 minutes into the test the first circuit failed in the IMC conduit. The second circuit in the IMC conduit failed at 4:10 (see panel 3) followed by two additional circuit failures in the third minute of the test (see panel 4). At 4:11 (see panels 5, 6, and 7) the remaining circuits in the IMC conduit failed. **Significantly, not a single circuit in the schedule 40 PVC conduit had failed up to that point.**

At 4:14, seven minutes into the test, the first circuit in the schedule 40 PVC failed, quickly followed by a second circuit failure (panel 9), followed by five circuit failures at 4:15 (panels 10 and 11). Two of the remaining three circuits in the schedule 40 PVC failed at 4:18 (see panels 12 and 13). The last remaining circuit in the schedule 40 PVC conduit (panel 14) remained illuminated when the test was terminated at 4:24.

minutes. All circuit indicating lights monitoring the circuits in the IMC conduit had gone dark within four minutes. Nine circuit indicating lights monitoring the circuits in the schedule 40 PVC conduit had extinguished within 10 minutes. One circuit indicating light continued to function until the test was terminated after 17 minutes.
