At Carlon, We Know How To Treat A Lady.

A Solution

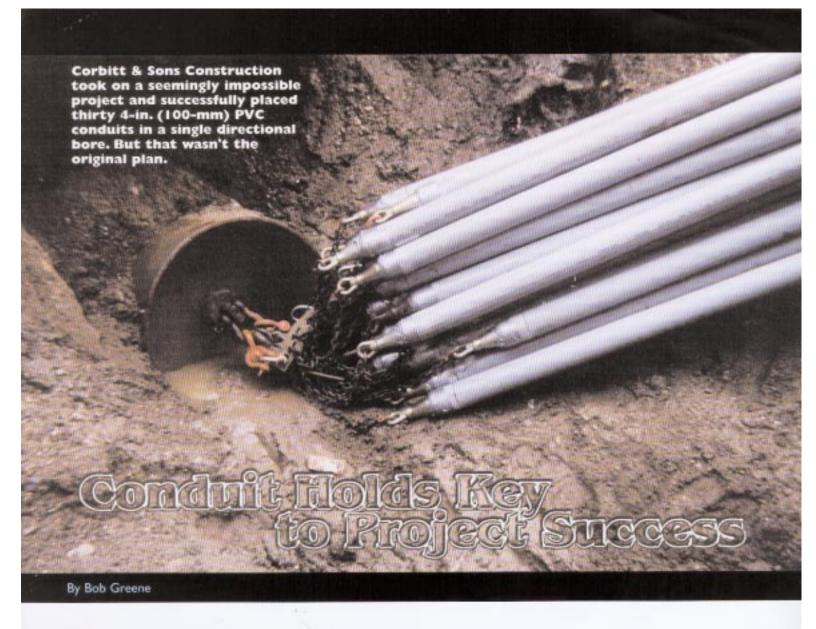
Matching grooves and plastic locking strap allow fast, cement-free assembly Positive stop automatically aligns strap grooves

Triple-lobed gasket forms a water-tight seal

Heavy walls and deep insertion make joints immune to effects of normal bending

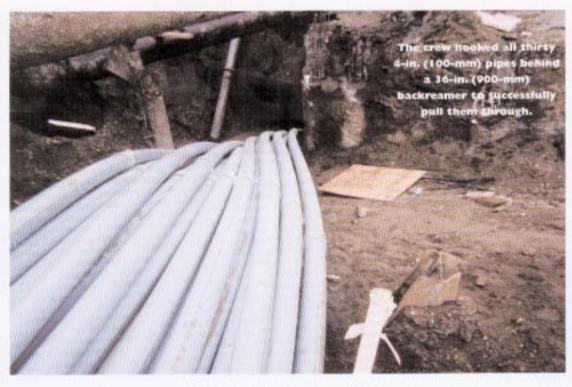
Using a Vermeer D80 rig, 15-ft (4.5m) rods, and a 6-in. (150-mm) pilot bit, the first shot at the 180-ft (55-m) bore

was attempted. They lost the signal, so they had to pull it back. A combination of depth and interference from the other utilities really made it tough.
