FIRE CHIEFS
investigate, demonstrate and
SPEAK OUT
ON FIRE SAFETY.

OPERATION SAN FRANCISCO

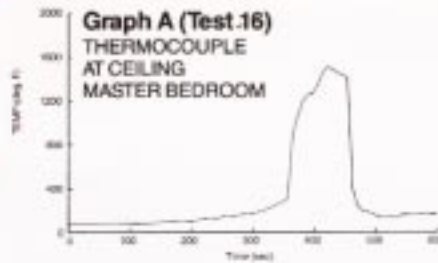
1 This wall receptacle in the apartment master bedroom shows the extent of fire damage to bed frame, wall and outlet plate, while circuit operation is demonstrated by light. Recorded room temperatures are shown in Graph A. See Diagram II.

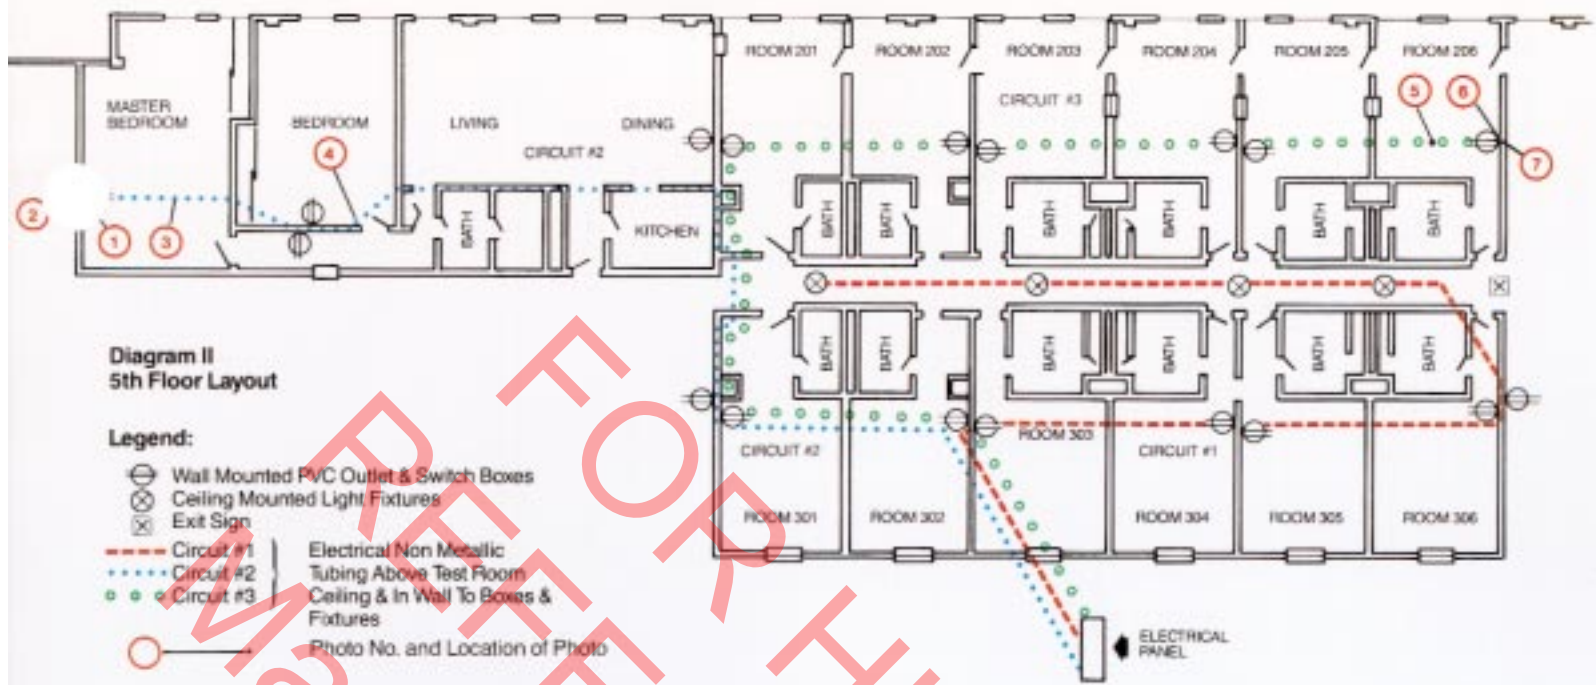
3 Electrical nonmetallic tubing running across ceiling of apartment master bedroom showing effects of fire but tubing intact. See Diagram II.
