FIRE CHIEFS
investigate, demonstrate and
SPEAK OUT
ON FIRE SAFETY.

A documentation of actual tests,
demonstrations and results from segments of

OPERATION SAN FRANCISCO

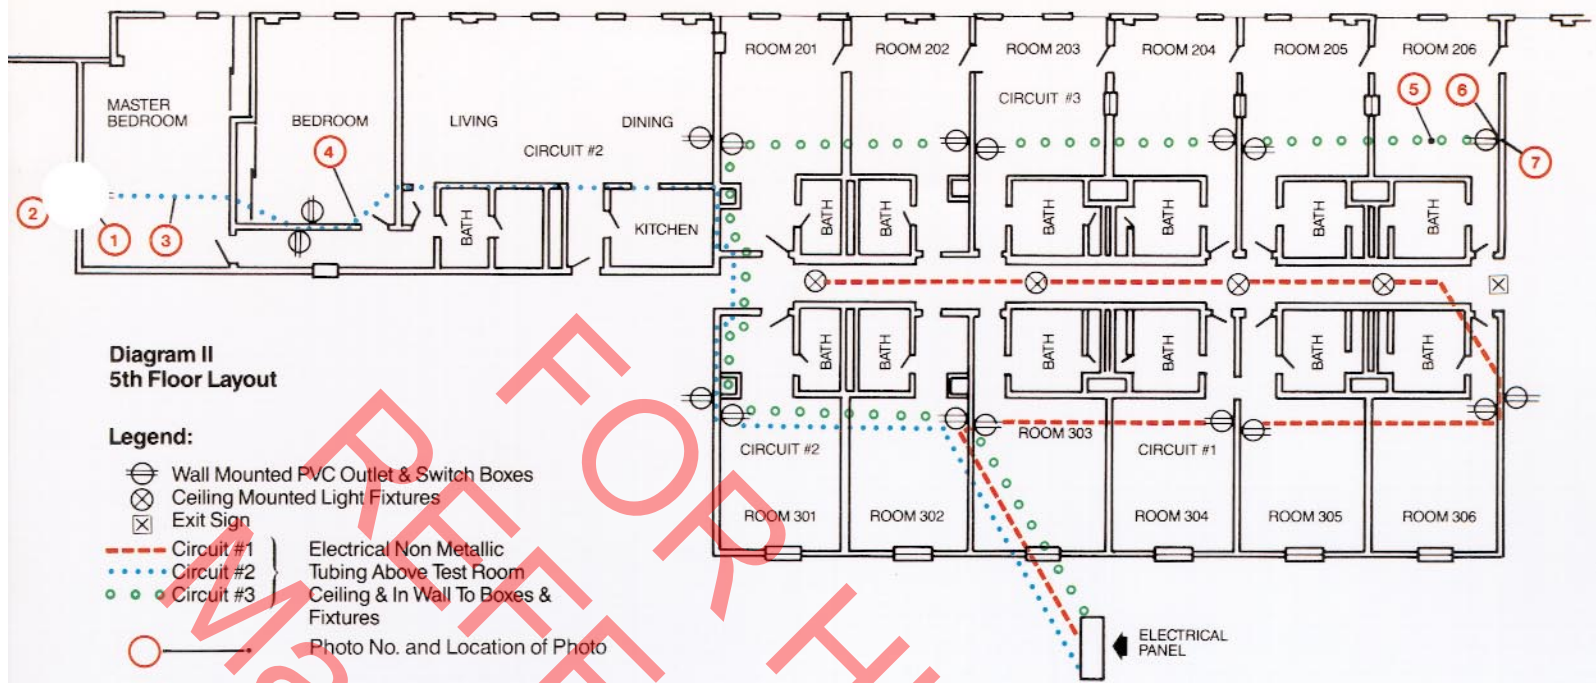
3 Electrical nonmetallic tubing running across ceiling of apartment master bedroom showing effects of fire but tubing intact. See Diagram II.

4 ENT™ running above apartment bedroom showing coupling for tubing. See Diagram II.
