FIRE CHIEFS
investigate, demonstrate and
SPEAK OUT
ON FIRE SAFETY.

OPERATION SAN FRANCISCO

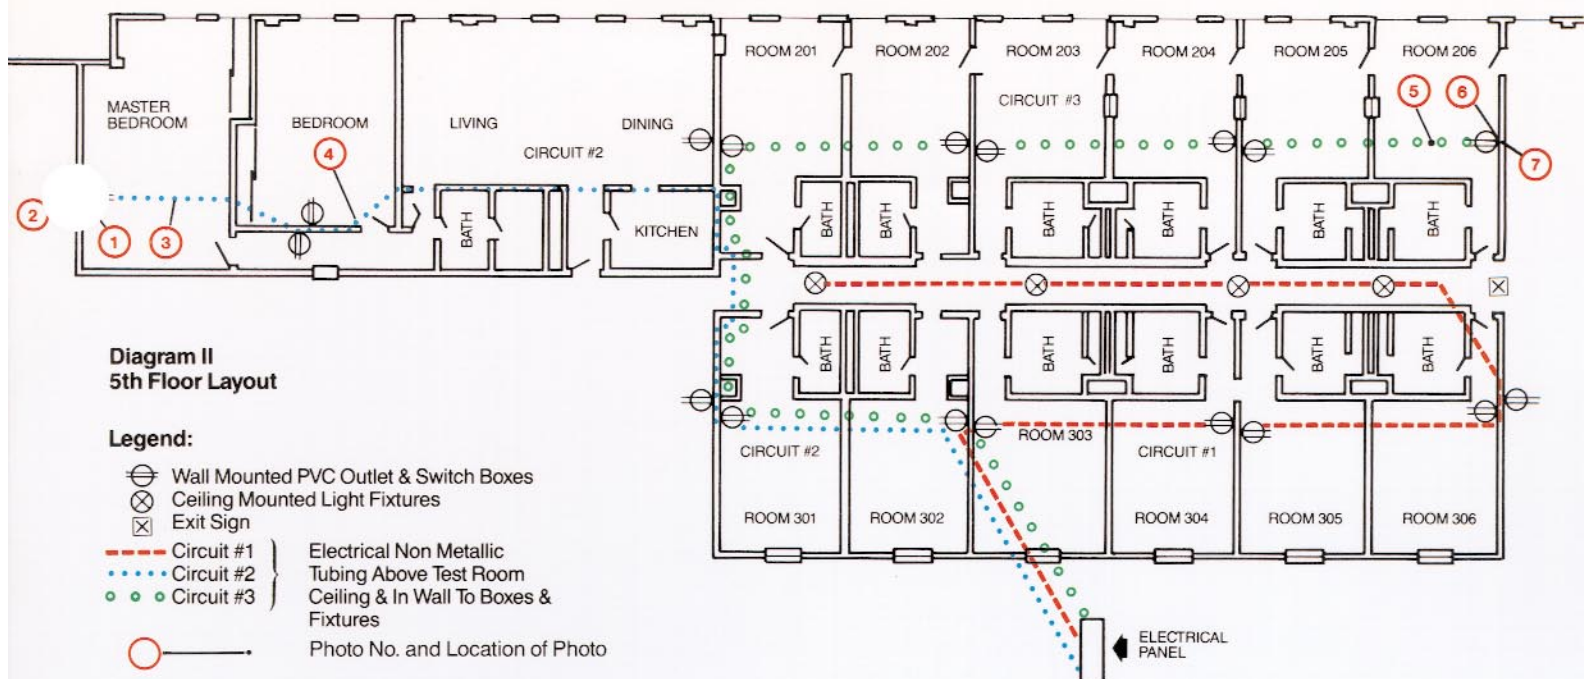
3 Electrical nonmetallic tubing running across ceiling of apartment master bedroom showing effects of fire but tubing intact. See Diagram II.
